TECHNICAL MEMORANDUM

November 8, 2024

**RE: Town-Wide Culvert Assessment
Town of Braintree, MA**

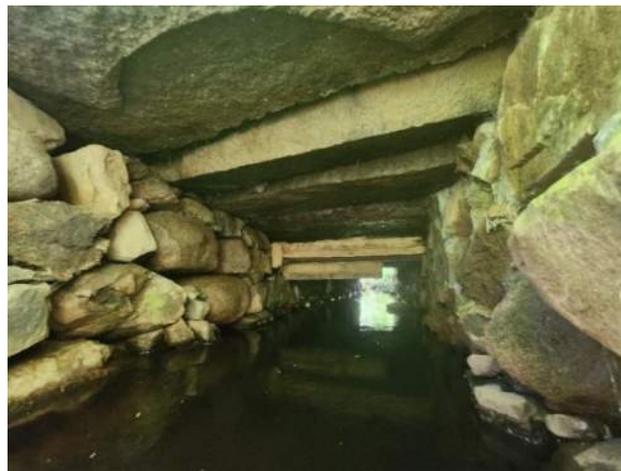
Figure 2: Culvert #24

- Culvert #24 – 7'x7' Stone Stetson St Culvert:** The existing 7'x7' stone culvert is unstable, and sinkholes have formed on the surface above the culvert. EP completed the preliminary design for this culvert in June 2020. We recommended the replacement of the existing culvert with an 18'x6' arch culvert and the installation of new headwalls and wingwalls.

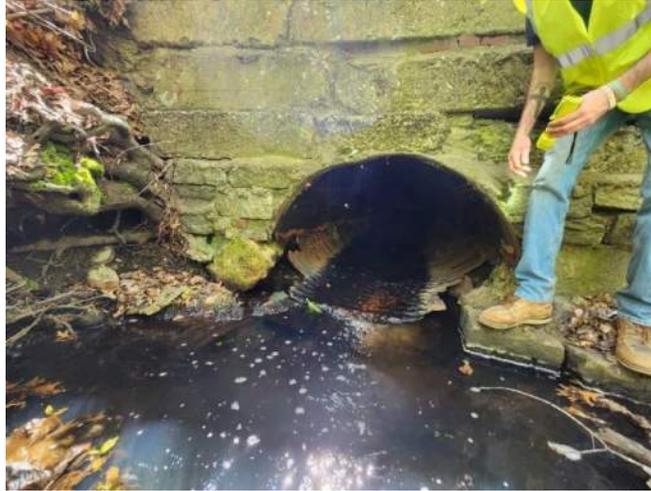
Figure 3: Culvert #7 Outlet

- **Culvert #7 – 48” CMP Pearl St Culvert:** The existing 48” CMP culvert is corroded and deformed throughout the length of the culvert. The banks of the stream upstream of the culvert inlet are at risk of erosion and blocking the culvert inlet. We recommend the replacement of the existing culvert with a 5'x3' concrete box culvert and adjustment of the alignment, installation of headwalls and wingwalls, and regrading of the stream banks to prevent further erosion.

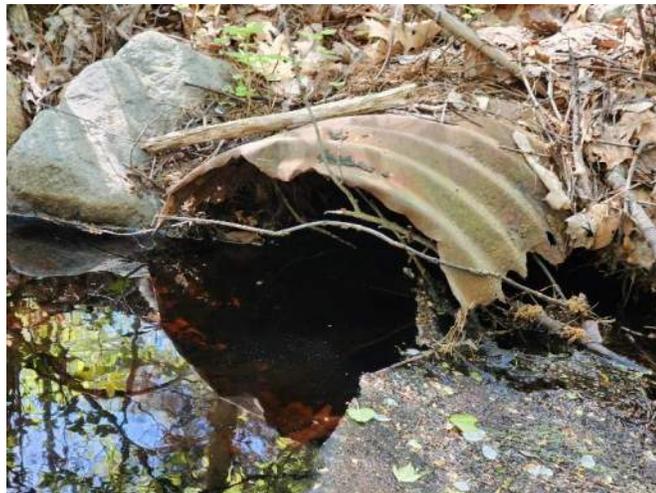
Figure 4: Culvert #4 Outlet

- **Culvert #4 – 18” CMP Culvert under Trail/Easement near Claire St:** The existing 18” CMP culvert is severely corroded and missing a bottom. In addition, it is undersized. We recommend demolishing the culvert and daylighting the stream if there are no conflicting utilities present.

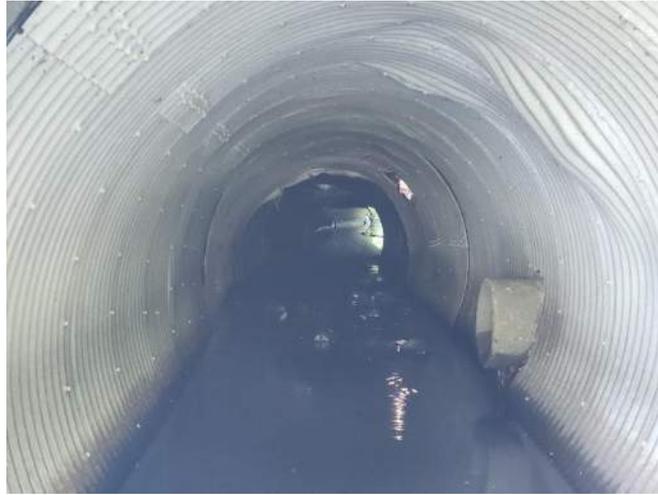
Figure 5: Culvert #19

- **Culvert #19 – 48” CMP Faulkner PI Culvert:** The roof of the existing 48” CMP culvert is collapsing, and the culvert is deformed throughout the length of the culvert. The pavement above the culvert is sagging, cracked, and at risk of sinkhole formation. We recommend the replacement of the existing culvert with an 8’x4’ concrete box culvert and the installation of headwalls and wingwalls.

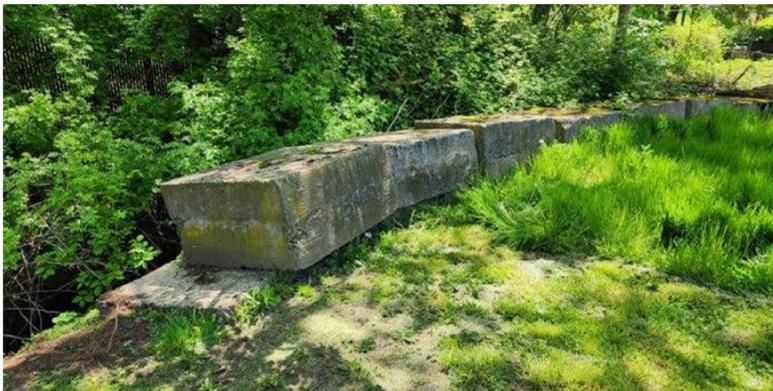
Additional Notes
Culvert pipe is in bad condition, incoming pipe penetration needs to be investigated, looks like it's from sewer? Erosion present. Cement blocks near inlet side could block culvert if they slide.

Leaning concrete block wall along inlet side

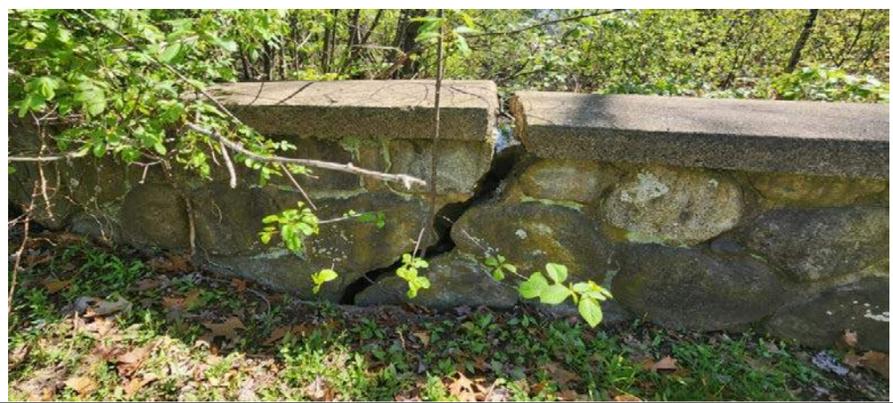
Crack in headwall at outlet

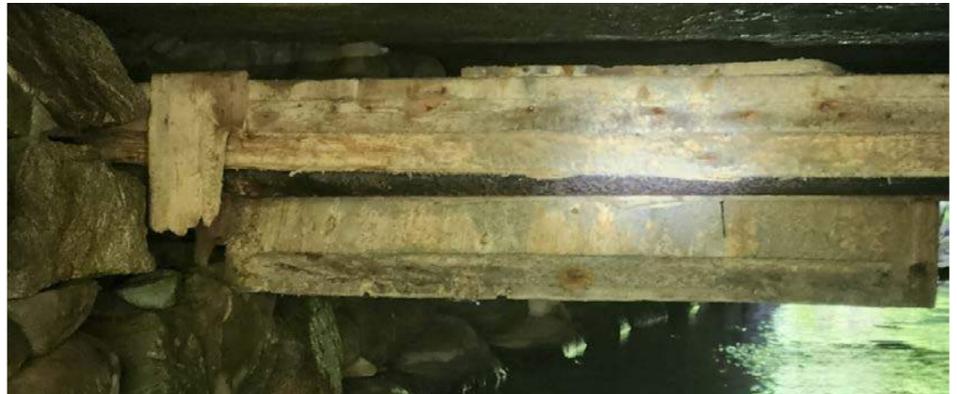
Additional Notes
Utility pipe going across the culvert width in the culvert on the outlet side. Wood planks surrounding the utility pipe. Culvert showing clear signs of age and should be replaced. Sinkholes present off the edges of the road along the culvert alignment.

Utility pipe on outlet side
