TOWN OF BRAINTREE - AFFORDABLE HOUSING STUDY 74/90 POND STREET

EXISTING CONDITIONS FINDINGS

APRIL 11, 2024

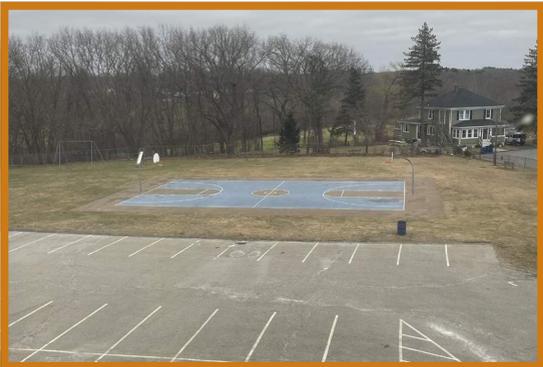
SPORTS/PLAY AREA

- » Located behind the back parking area, a basketball court, metal swing set, and metal slide.
- » Equipments are in poor condition with no accessible connection.

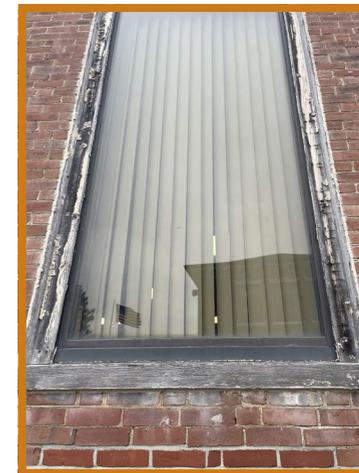
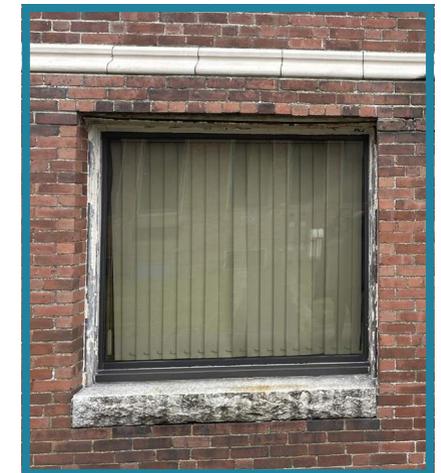
DOORS & WINDOWS - 90

- » Exterior wood window trim is in poor shape, existing steel lintels at lower level are rusted and failing. Stone sills and headers are in decent shape, some cracking visible. Windows are fixed glass units, some broken. Exterior doors have inappropriate hardware. **Replace exterior window trim and window units with operable units. Replace steel lintels, cracked stone sills and headers. Install new door hardware. Reflash & seal openings.**

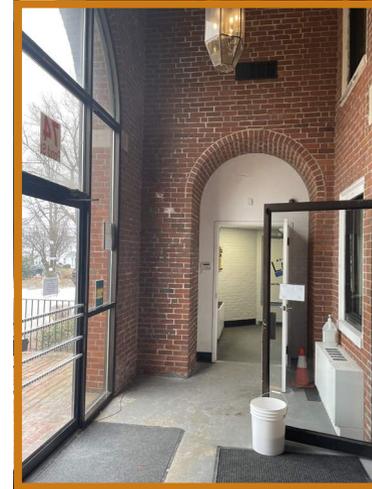
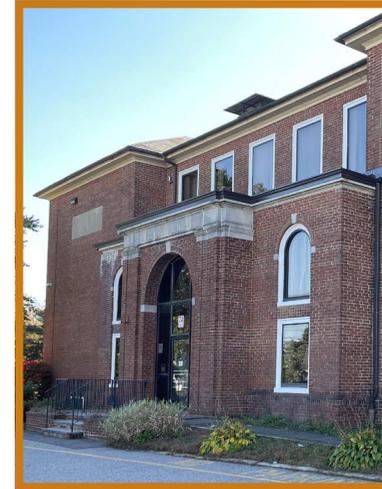
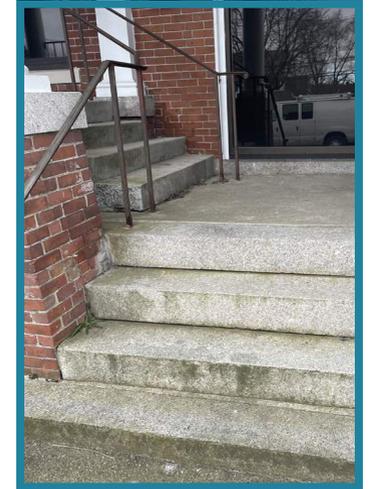
ENTRY VESTIBULE - 74

- » Brick and stone cap stairs and accessible sloped path lead to front entry vestibule. Railing at stair not to code. **Code: Replace railings with code compliant.**
- » Vestibule interior in good condition, some paint finishes peeling, front entry door not to code. **Repair and repaint wood trim. New compliant door with closing hardware.**

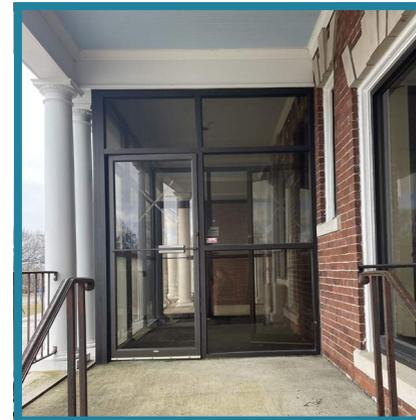
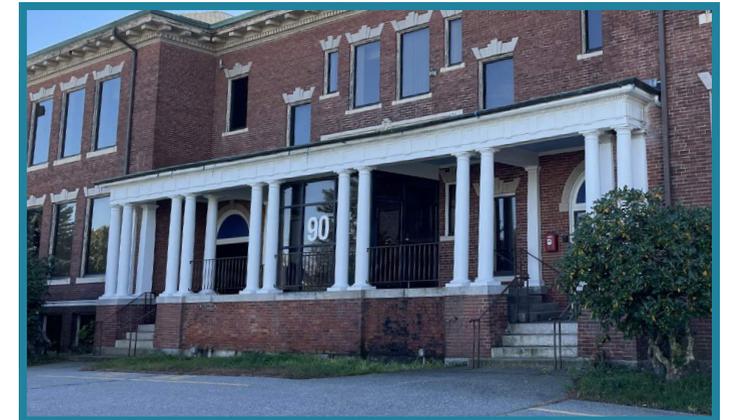
ENTRY VESTIBULE - 90

- » Granite stone steps and metal railing. Inaccessible entry from sidewalk. **Code: Provide accessible route to front door.**
- » Railings & guardrail not to code. **Code: Replace railings with code compliant.**
- » Peeling paint at wood finishes, brick spalling visible. **Repair and repaint wood trim. Replace missing column. Repoint brick as required.**

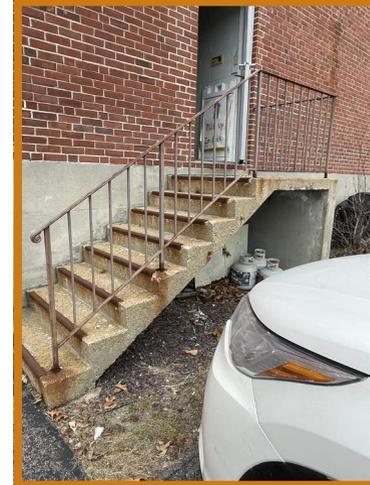
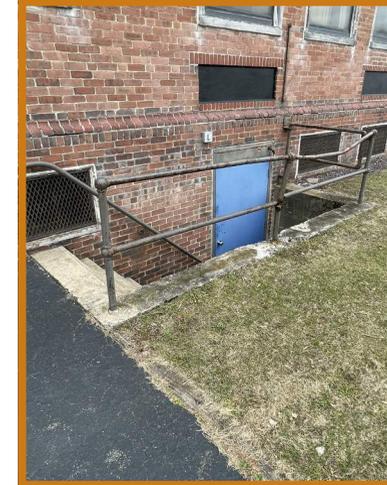
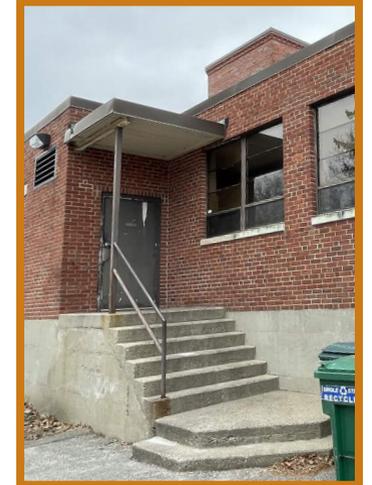
ADDITIONAL POINTS OF ENTRY - 74

- » Existing entry points are not accessible. **Make accessibility upgrades as required if intended for public use.**
- » Railings at all stairs are damaged or not to code. **Replace with code compliant railing.**
- » Rear door not level with egress. **Adjust entry for flush entry.**

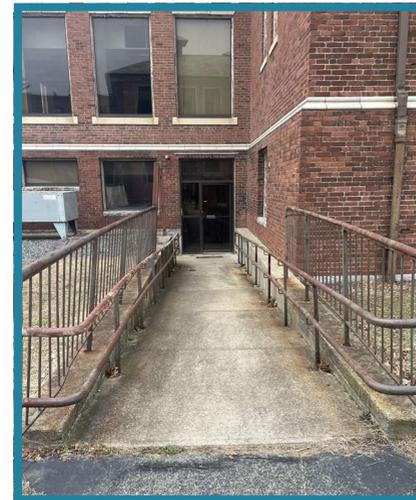
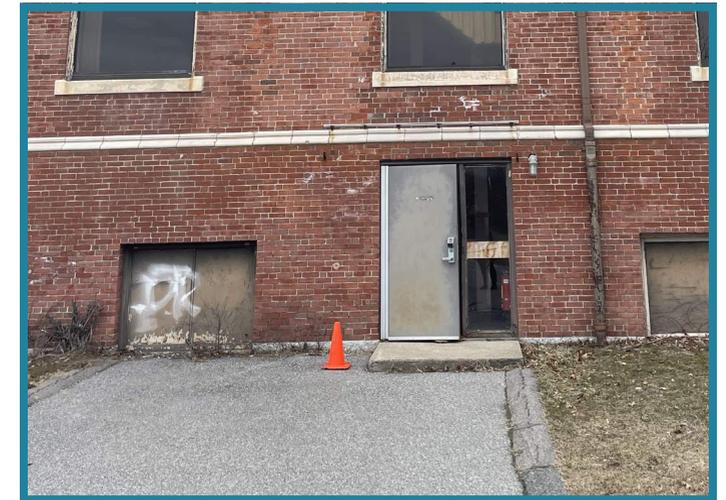
ADDITIONAL POINTS OF ENTRY - 90

- » Existing entry points are not accessible. **Make accessibility upgrades as required if intended for public use.**
- » Railing at rear ramp is damaged. **Replace with code compliant railing.**
- » Rear door not level with egress. **Adjust entry for flush entry.**

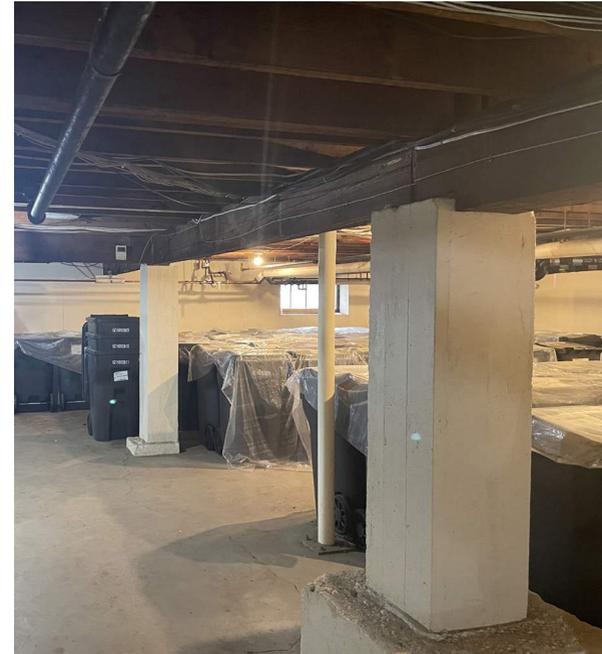
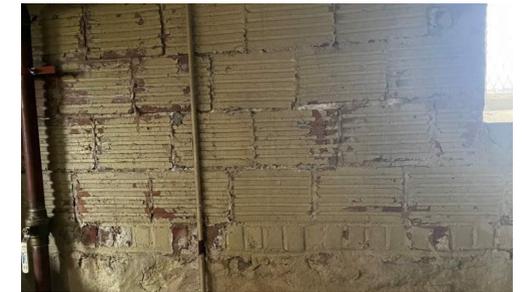
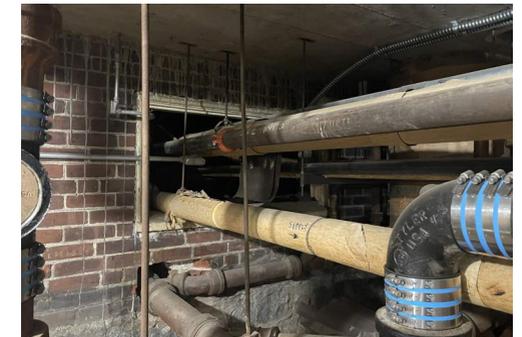
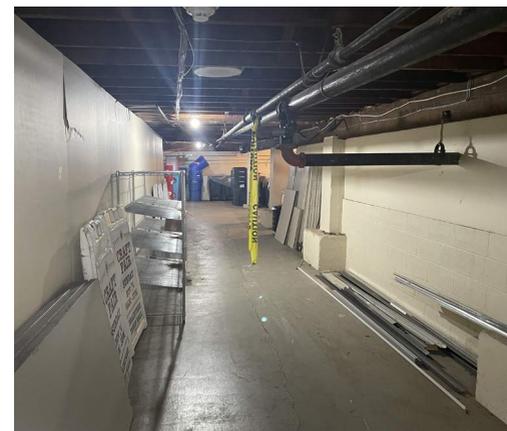
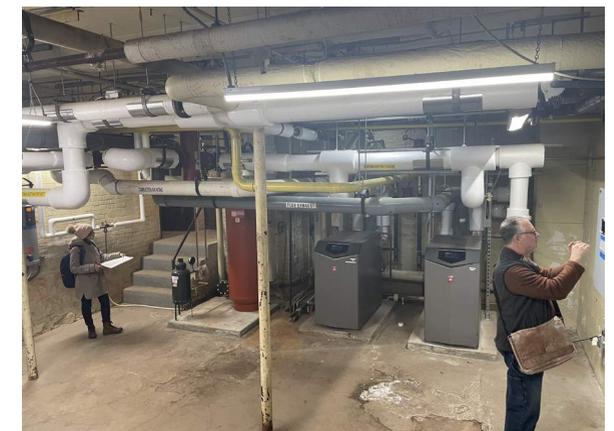
BASEMENT - 74 - OBSERVATIONS

- » Level change at center section of structure and auditorium stage, ramp without railing.
- » Existing brick masonry have visible spalling & deterioration.
- » Existing piping limits accessibility through southeast corner of basement level.

- » Repoint masonry walls & chimney where required.
- » See MEP & Structural recommendations.

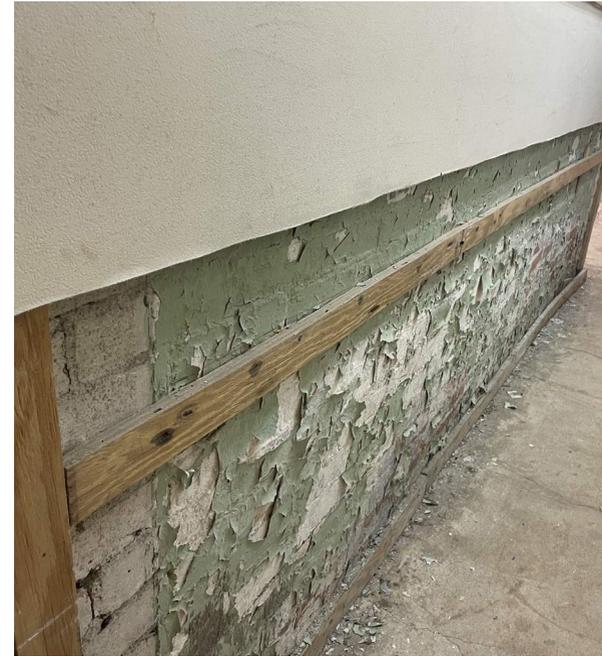
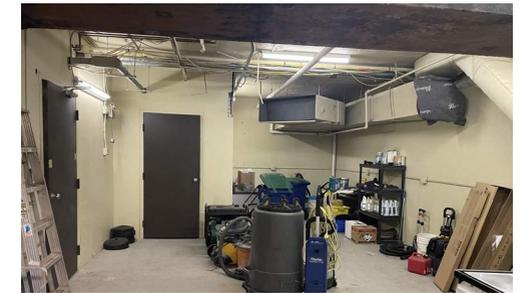
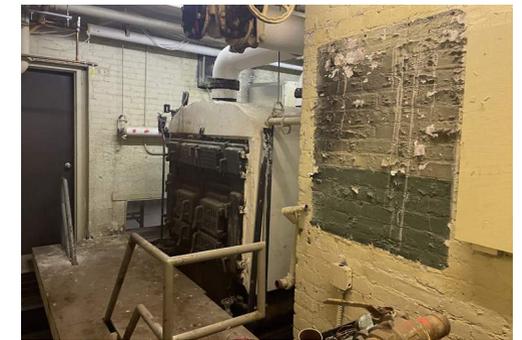
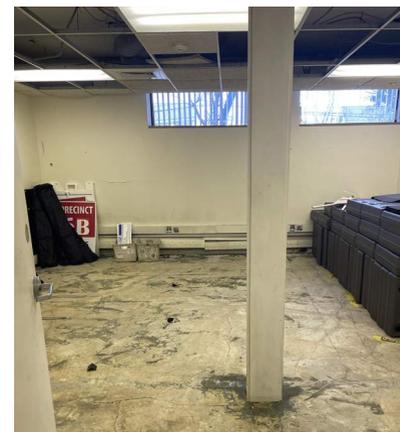
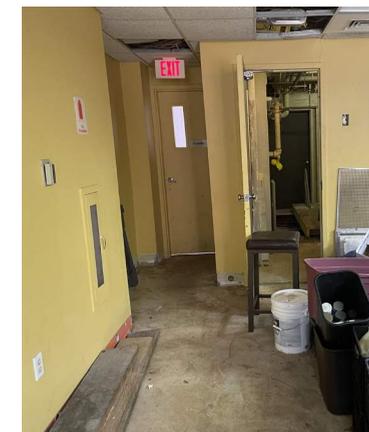
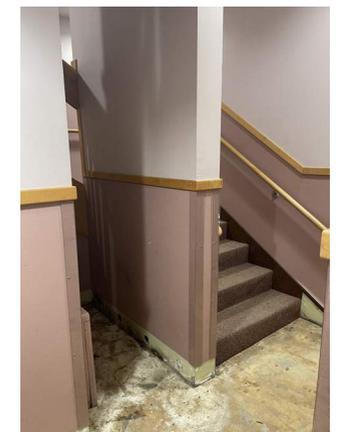
BASEMENT - 90 - OBSERVATIONS

- » Both sets of stairs & railings are not to code. Railing height, extensions noncompliant. Main stair width tight.
- » Interior finishes are damaged and outdated.
- » Cracked concrete slab on grade.
- » Obsolete mechanical equipment throughout.

- » Code: Multiple issues with existing railings & stairs, extent of changes will be based on final scope of work.
- » Repoint masonry walls and new finishes as required.
- » See MEP & Structural recommendations.

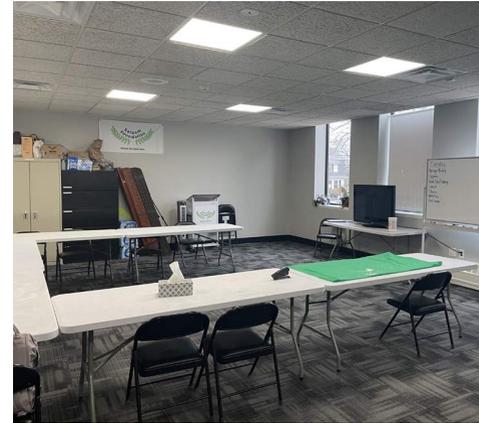
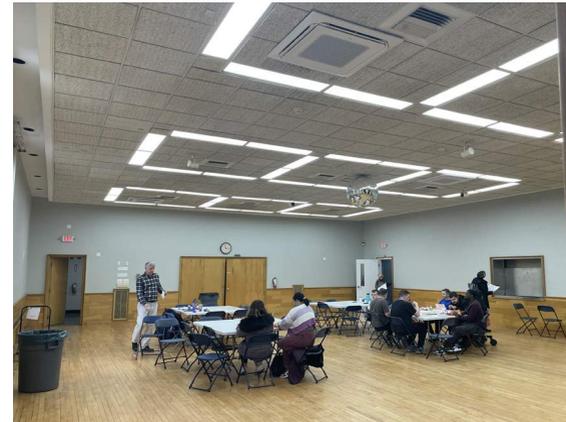
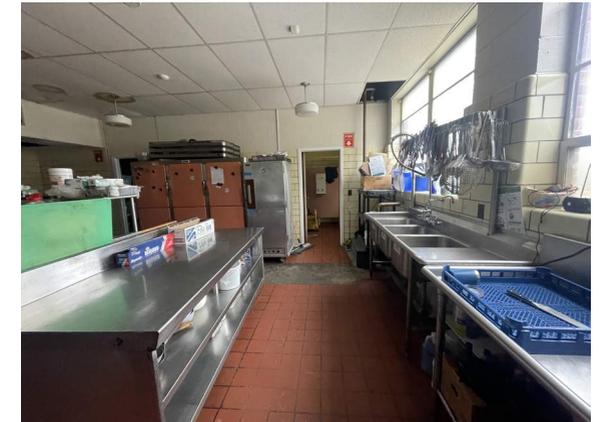
FIRST FLOOR - 74 - OBSERVATIONS

- » Ramp railings are not to code at both stairs and ramps.
- » Interior finishes throughout in fair to good condition.
- » Level changes at center section of structure and auditorium stage.
- » Kitchen finishes, equipment and fixtures in fair to good condition. See MEP recommendations.

- » **Code: Accessibility layout changes and upgrades to all public spaces.**
- » **Consider how to best mitigate level change with new design.**
- » **Consider: reusing existing kitchen layout and equipment, replace finishes as required.**
- » **See MEP & Structural Recommendations**

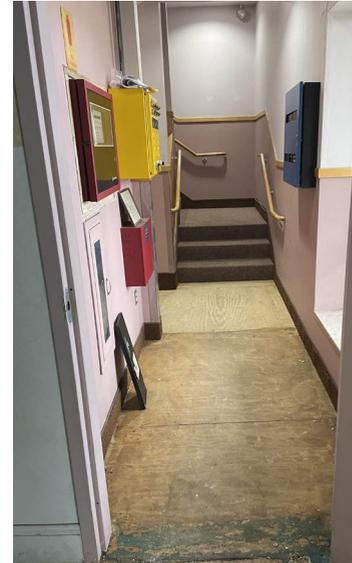
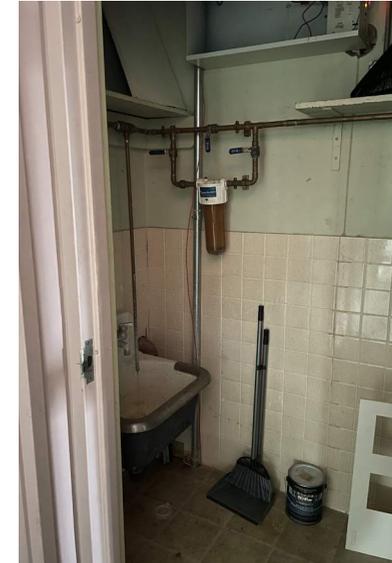
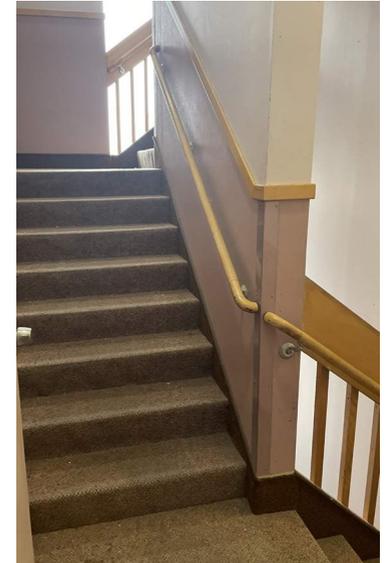
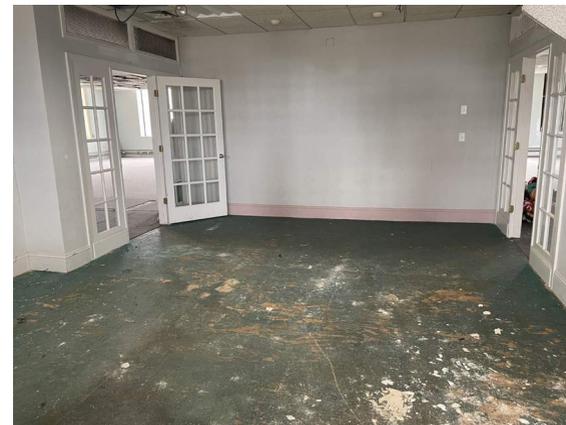
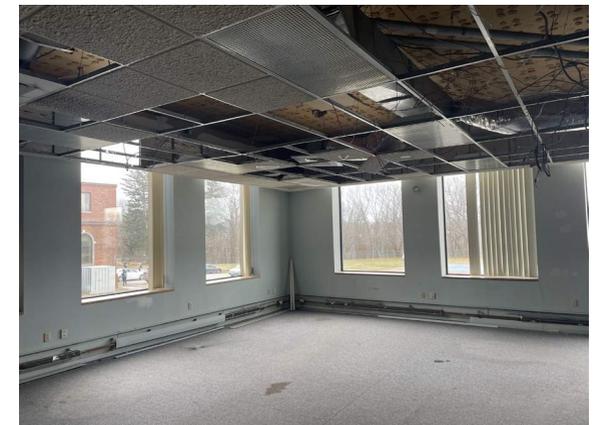
FIRST FLOOR - 90 - OBSERVATIONS

- » Both sets of stairs & railings are not to code. Railing height, extensions noncompliant. Main stair width tight.
- » ACT suspended system damaged.
- » Plumbing fixtures & interior finishes are damaged and outdated.

- » **Code:** Multiple issues with existing railings & stairs, extent of changes will be based on final scope of work.
- » Replace interior finishes throughout.

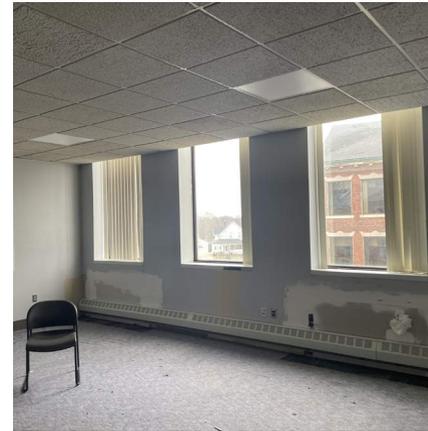
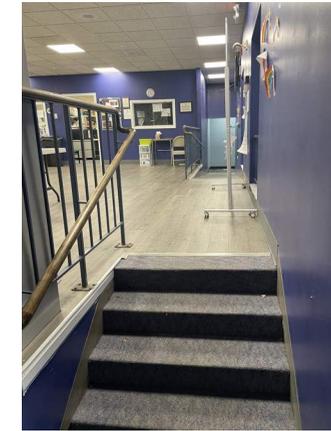
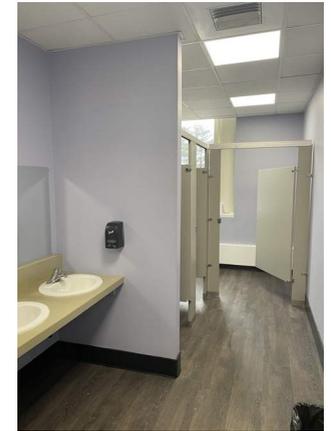
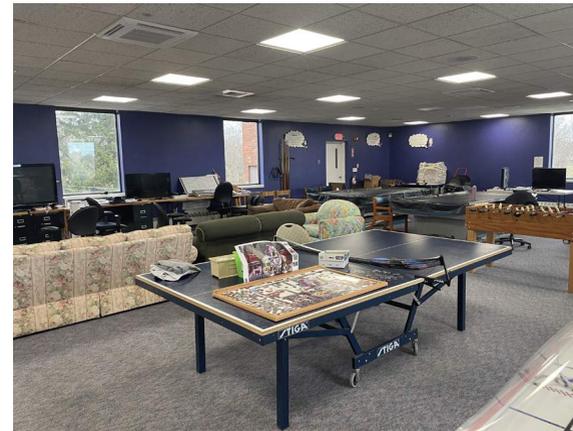
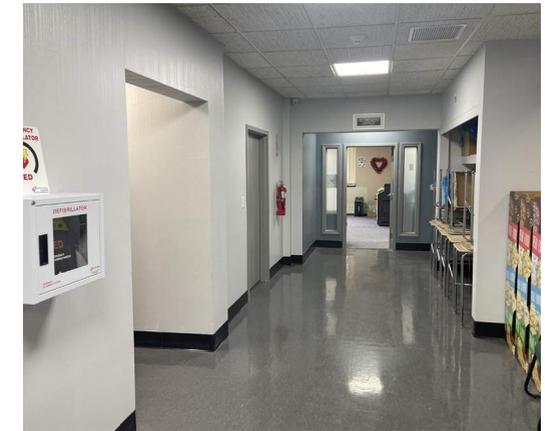
SECOND FLOOR - 74 - OBSERVATIONS

- » Ramp railings are not to code.
- » Bathroom finishes are outdated.
- » Level change above auditorium.

- » **Code:** Multiple issues with existing railings, extent of changes will be based on final scope of work.
- » Consider how to best mitigate level change with new design.
- » Replace interior finishes as required.

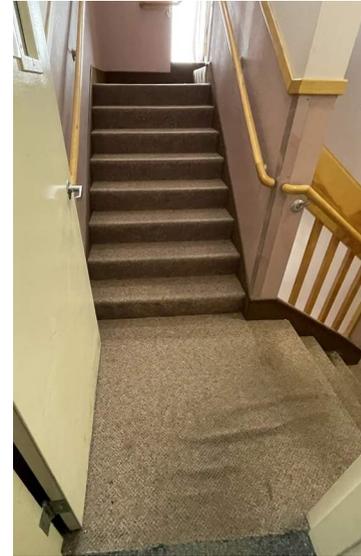
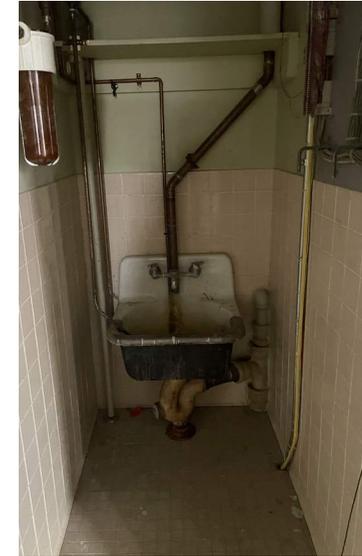
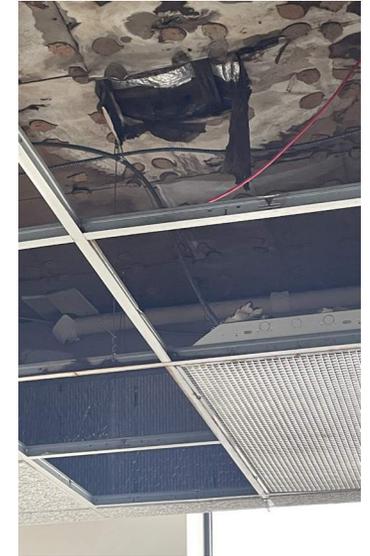
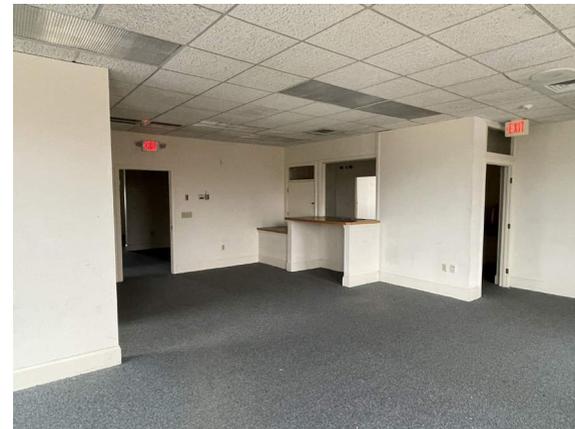
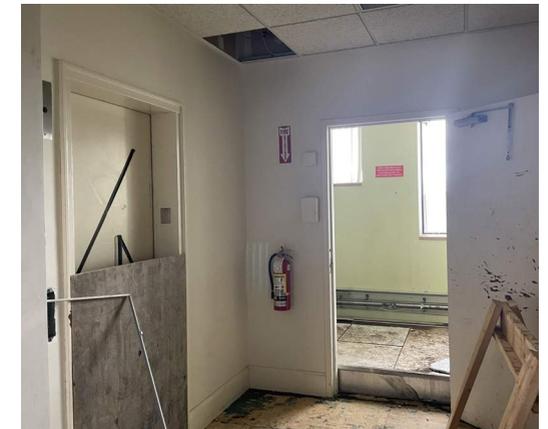
SECOND FLOOR - 90 - OBSERVATIONS

- » Both sets of stairs and railings are not to code. Railing height, extensions noncompliant. Main stair width tight.
- » Interior finishes are damaged and outdated.
- » Water infiltration from southwest roof valley leak has damaged finishes.
- » ACT suspended system damaged.

- » **Code: Multiple issues with existing railings & stairs, extent of changes will be based on final scope of work.**
- » **Replace interior finishes throughout.**

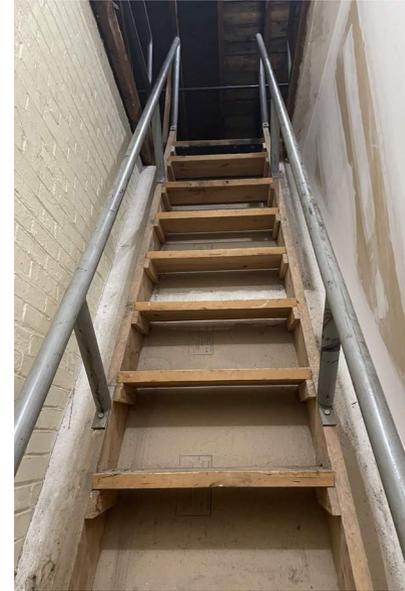
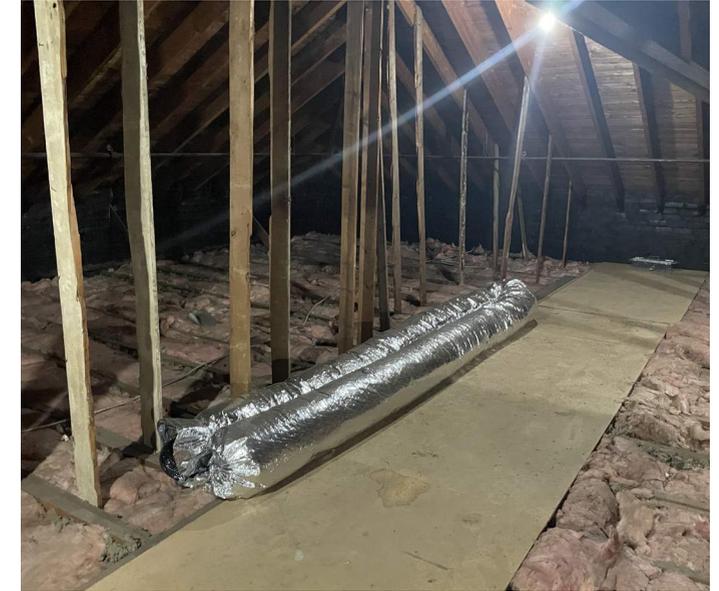
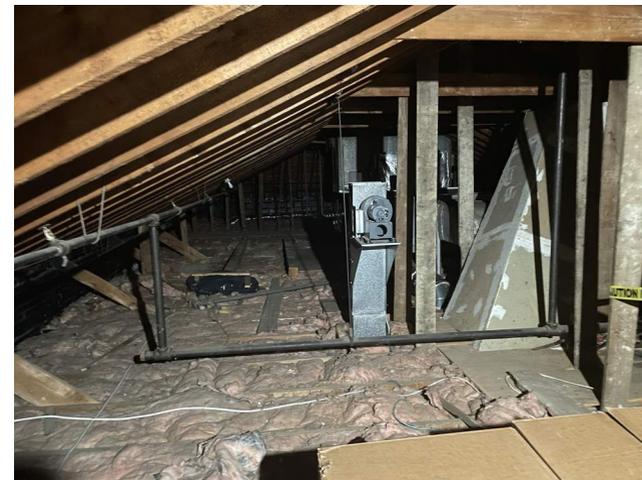
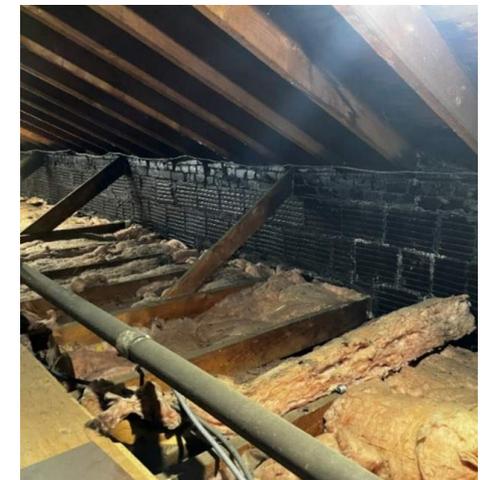
ATTIC - 74 - OBSERVATIONS

- » Entire attic unfinished. Cold attic does not include insulation visible at roof framing. Batt insulation at attic floor framing.
- » Only attic access requires use of fixed vertical ladder.
- » Both brick masonry ventilation stacks & top of exterior walls have visible spalling.
- » Ventilation and ductwork systems

- » Install insulation at roof structure per energy code.
- » See structural recommendations.
- » Repoint brick masonry and top of exterior wall.
- » Consider new stair and extension of elevator shaft, and addition of dormers to make livable space in attic.

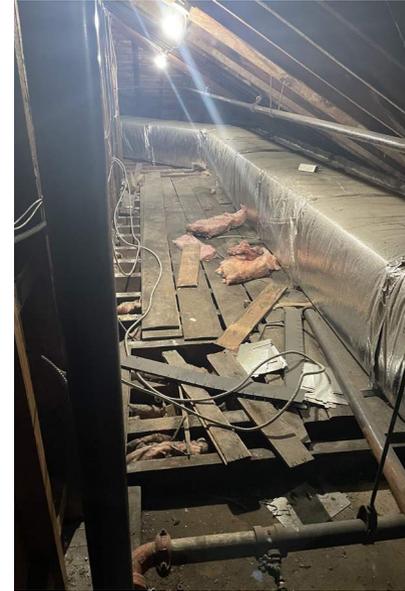
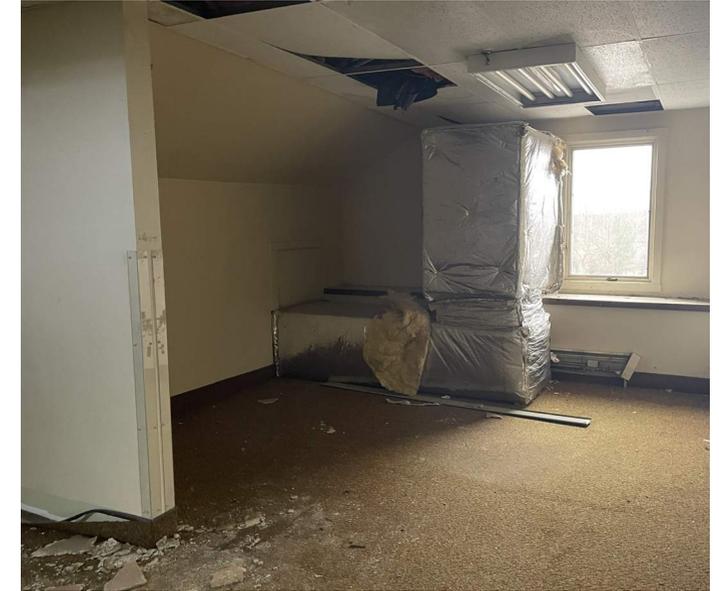
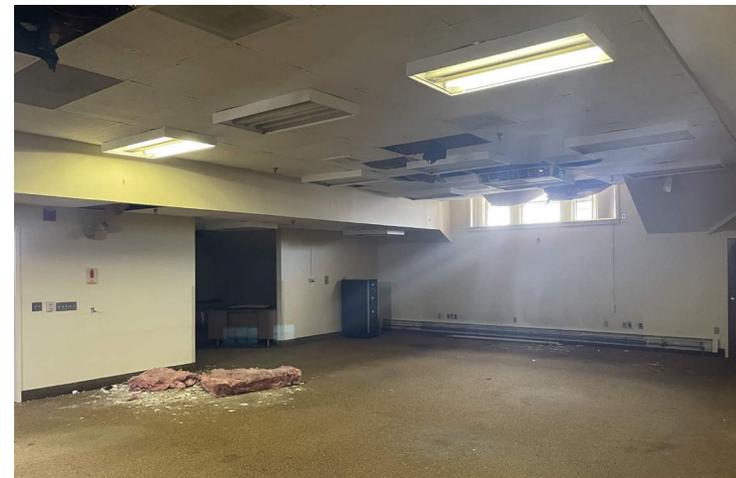
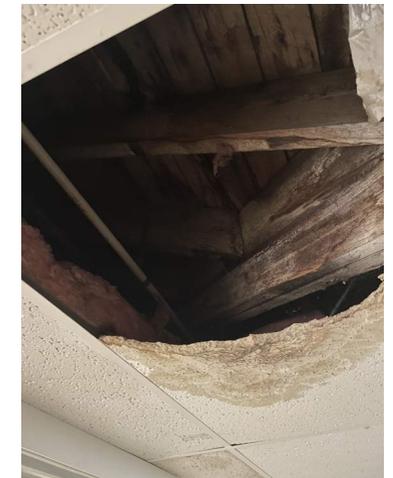
ATTIC - 90 - OBSERVATIONS

- » Center structure finished interior attic space. Finishes damaged throughout. Ductwork and ventilation access through dormer windows.
- » Roof leak at southwest valley - damaged interior finishes.
- » Side wings of attic unfinished. Cold attic does not include insulation visible at roof framing.
- » Both chimneys have some visible spalling.

- » Replace interior finishes throughout.
- » Investigate roof penetrations for water infiltrations.
- » Install insulation at roof structure per energy code.
- » See structural recommendations.
- » Repoint chimneys and top of exterior wall.

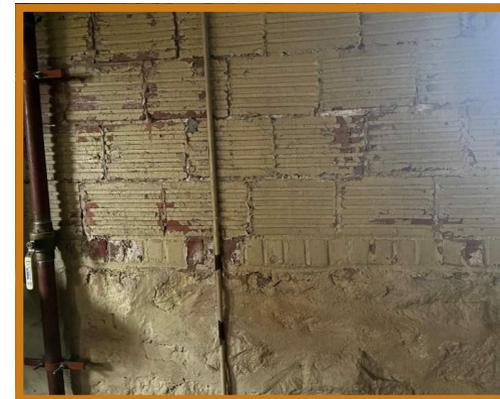
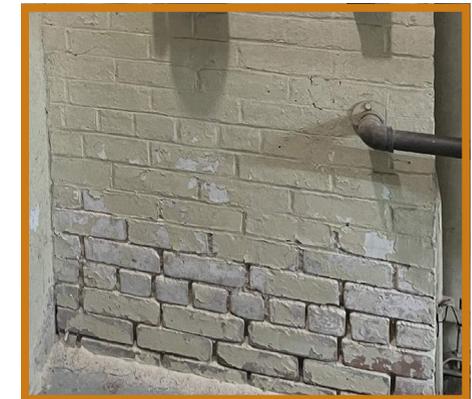
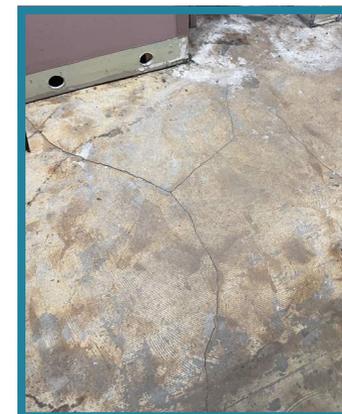
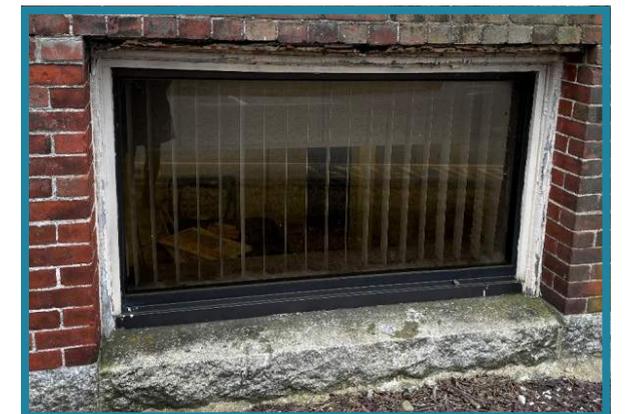
BASEMENT - MINIMAL SCOPE - REPAIRS

- » 74 - The existing structure is supported on a shallow foundation in good condition. The slab on grade had visible cracking but no evidence of settling (good condition). Rusting visible at supporting steel columns and some spalling at the mechanical room. Sonotubes supporting first floor framing in great condition.
- » **Recommend: evaluate existing damaged structural members to determine required reinforcement or replacement if needed. Repair spalling in mechanical room.**
- » 90 - The existing structure construction appears to match 74 Pond. Existing foundation walls are brick on granite blocks with no signs of settlement from exterior (not visible from interior). Slab on grade has extensive cracking and is assumed from poor concrete mix or lack of welded wire mesh in the

slab. Other than cracks, slab is in good condition without any signs of settlement. Steel lintels at basement windows are rusted and in poor condition.

- » **Recommend replacing rusted steel window lintels. Repair / seal cracks in basement as required.**

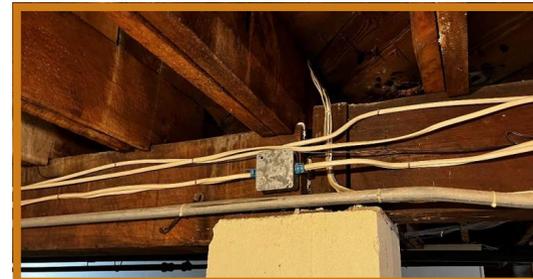
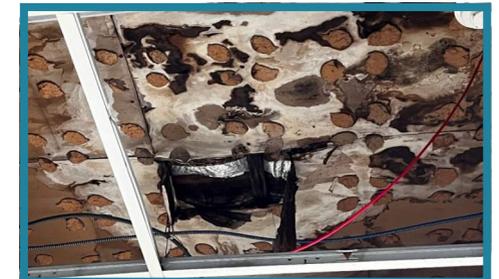
1ST, 2ND, & 3RD FLOORS - MINIMAL SCOPE - REPAIRS

- » 74 - First Floor framing visible in basement in good condition. Framing below auditorium and front lobby not accessible, but no significant signs of deflection or distressed. Second floor framing was not visible. Gypsum covering framing shows no signs of cracking or deflection. Floor finishes and walls above in good condition indicating decent condition.
- » **Recommend:** Majority of the structural framing members visible in good condition and can remain in place. Current framing will be able to carry live load of 40 PSF (living spaces). Reinforce / replace any notched or damaged structure.
- » 90 - Majority of first floor framing not visible from basement. Dropped 9" wood beams visible, supported on steel or cast-iron posts. Some locations where finishes removed indicate framing is in good condition. Same visibilities on 2nd &

3rd floor framing. Significant water infiltration observed in northeast corner below southwest roof valley.

- » **Recommend:** Majority of the structural framing members visible in good condition and can remain in place. Remove all finishes around water infiltration area to determine condition of wood framing. Current framing will be able to carry live load of 40 PSF (living spaces). Reinforce / replace any notched or damaged structure.

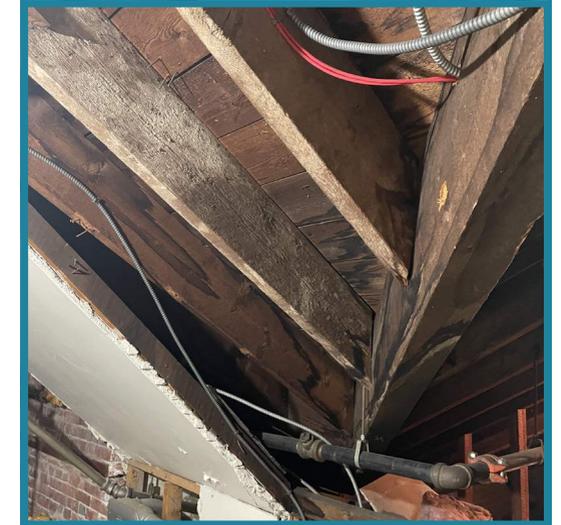
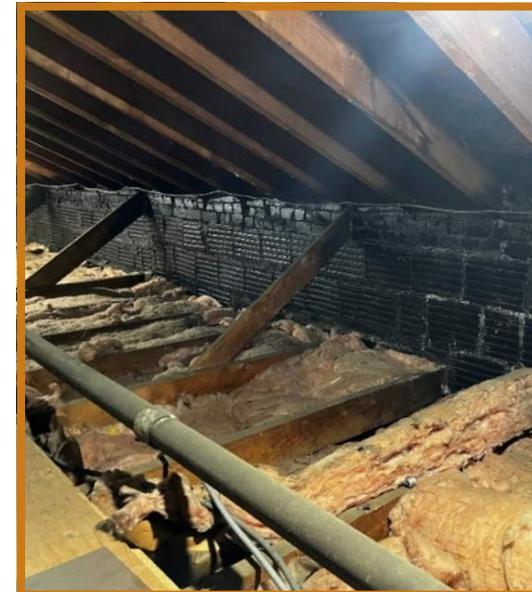
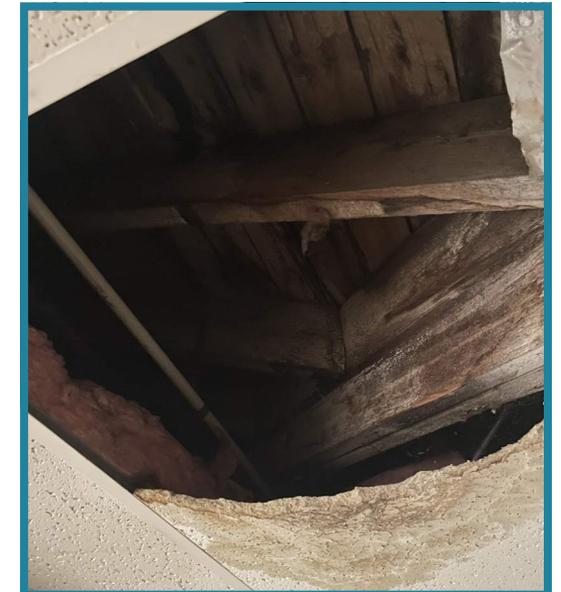
ATTIC - MINIMAL SCOPE - REPAIRS

- » 74 - The roof at the kitchen area includes steel beams supporting tectum roof panels. The original building includes hip and gable roof framing visible from the attic space, found to be in good condition. The roof above the auditorium was not visible but there was no visible signs of deflection.
- » **Recommend: any existing structural members found to be damaged will need to be evaluated for reinforcement or replacement, but otherwise good condition.**
- » 90 - Roof framing at center of building was mostly covered with finishes and not visible. Finishes show no sign of significant cracks. Framing includes 2x8 wood rafters framing to a 2x10 valley beam. Framing visible at both building ends in good condition. Rafters and beam in good condition with no sign of deflection or distress.

- » **Recommend: any existing structural members found to be damaged will need to be evaluated for reinforcement or replacement, but otherwise good condition.**

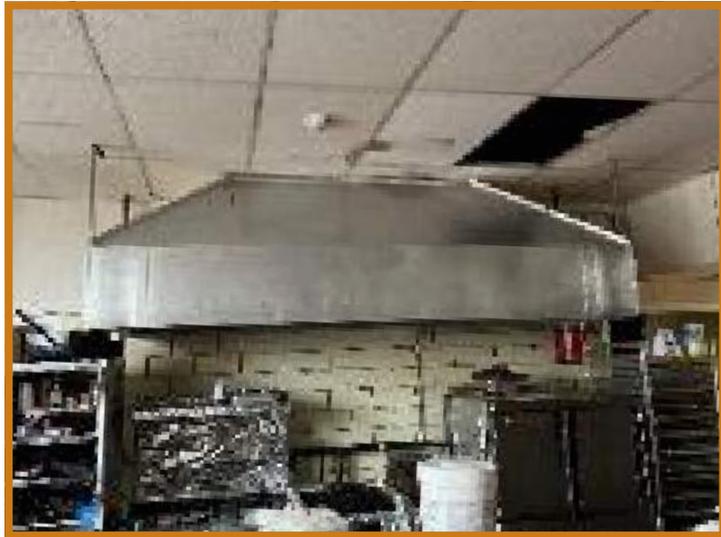
Kitchen Ventilation

- » 74 - Kitchen ventilation provided by Type 1 grease hood in fair condition with dry chemical type fire suppression system. Exhaust fan in fair to poor condition located on the flat roof above, likely not listed for grease exhaust. Make up air provided by an air handling unit in the basement pulling air from basement.
- » **Recommend: Replace kitchen exhaust fan and grease hood.**
