# Approved Sediment Sampling Plan

*Armstrong Dam Removal Feasibility Study*

Re: Armstrong Dam – Feasibility Study for Dam Removal, Revised Sediment Sampling Plan

# **Sediment Sampling Plan for Armstrong Dam Pond Monatiquot River, Braintree, MA**

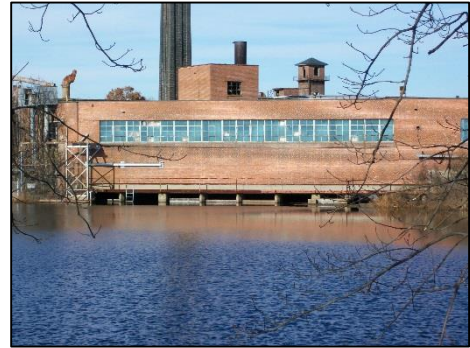
The Armstrong Dam is approximately 100 feet long consisting of nine equally sized 8-foot-wide bays as shown in the photograph. Vertical concrete columns between the bays extend from the spillway crest up to the base of the building. The dam is classified by MA Dam Safety as a high hazard structure.

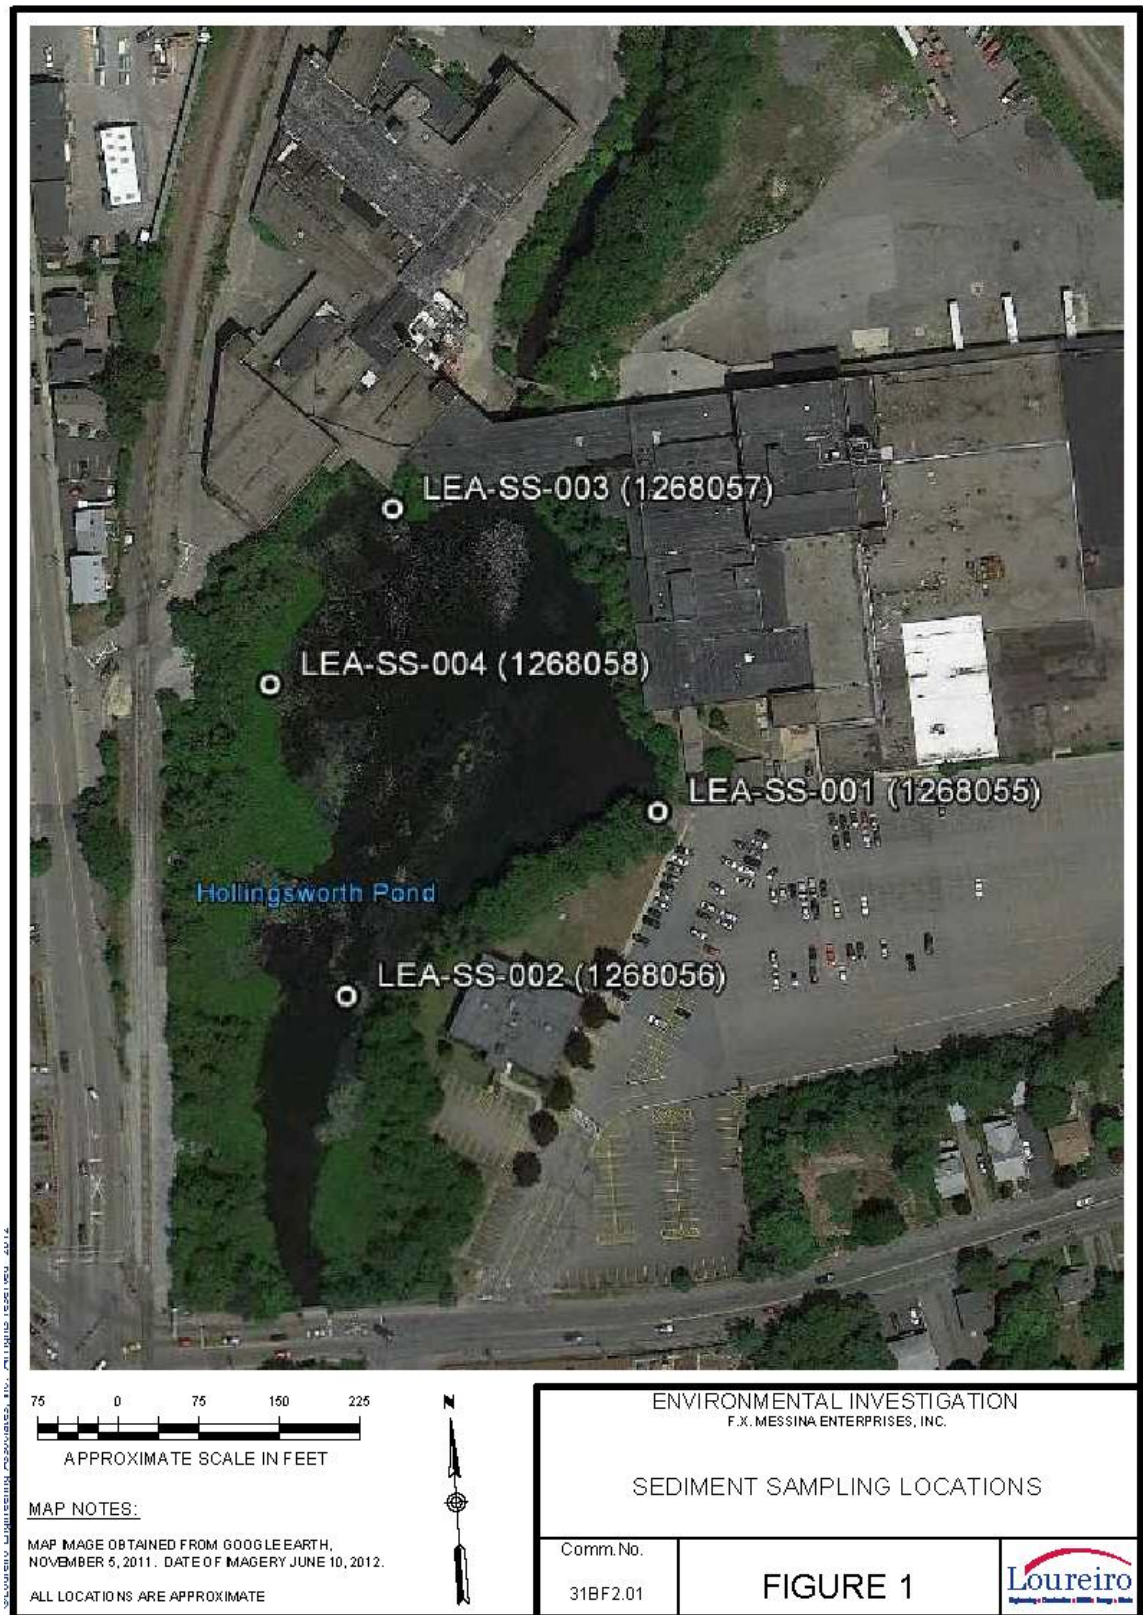
**Figure 3. Loureiro Sediment Sampling Locations**

The samples were distributed spatially to capture areas within the impoundment with sediments that would be exposed or mobilized if the dam was removed and to gather representative information regarding the sediment conditions. The sample locations are summarized below and shown in Figure 3.

- LEA-SS-001 was located along the eastern portion of the pond adjacent to the parking lot and its stormwater outfall.
- LEA-SS-002 was located along a shallow "sand" bar in the southern portion of the Pond mid-channel with the incoming river; upstream of the main portion of the Pond.
- LEA-SS-003 was located in the northwestern portion of the Pond adjacent to the junction of the channel spanning portion of the building and the portion of the building that occupies the western area of the Site.
- LEA-SS-004 was collected in the western portion of the Pond adjacent to a narrow vegetated buffer between the Pond and the commuter rail tracks.

On November 2, 2012, Loureiro collected shallow sediment samples from four locations in the Armstrong Dam impoundment as shown in Figure 3 (Figure 1 of the Loureiro report). Samples were collected using a 2-inch polyvinyl chloride (PVC) tube with an open end and a capped end with an air vent. The device was manually driven into the sediment until refusal upon which the air vent was closed and the tube retrieved. At the surface, the air vent was opened releasing the sediment from the tube.

The samples were collected in water depths of 1.25 to 3 feet and ranged from 2 inches to 3.83 feet below ground surface. Predominantly the sediment observed was dark brown/black silty-fine to medium sand with trace gravel. Sample location LEA-SS0003 had a notable petroleum odor at collection and a sheen was observed in the area.

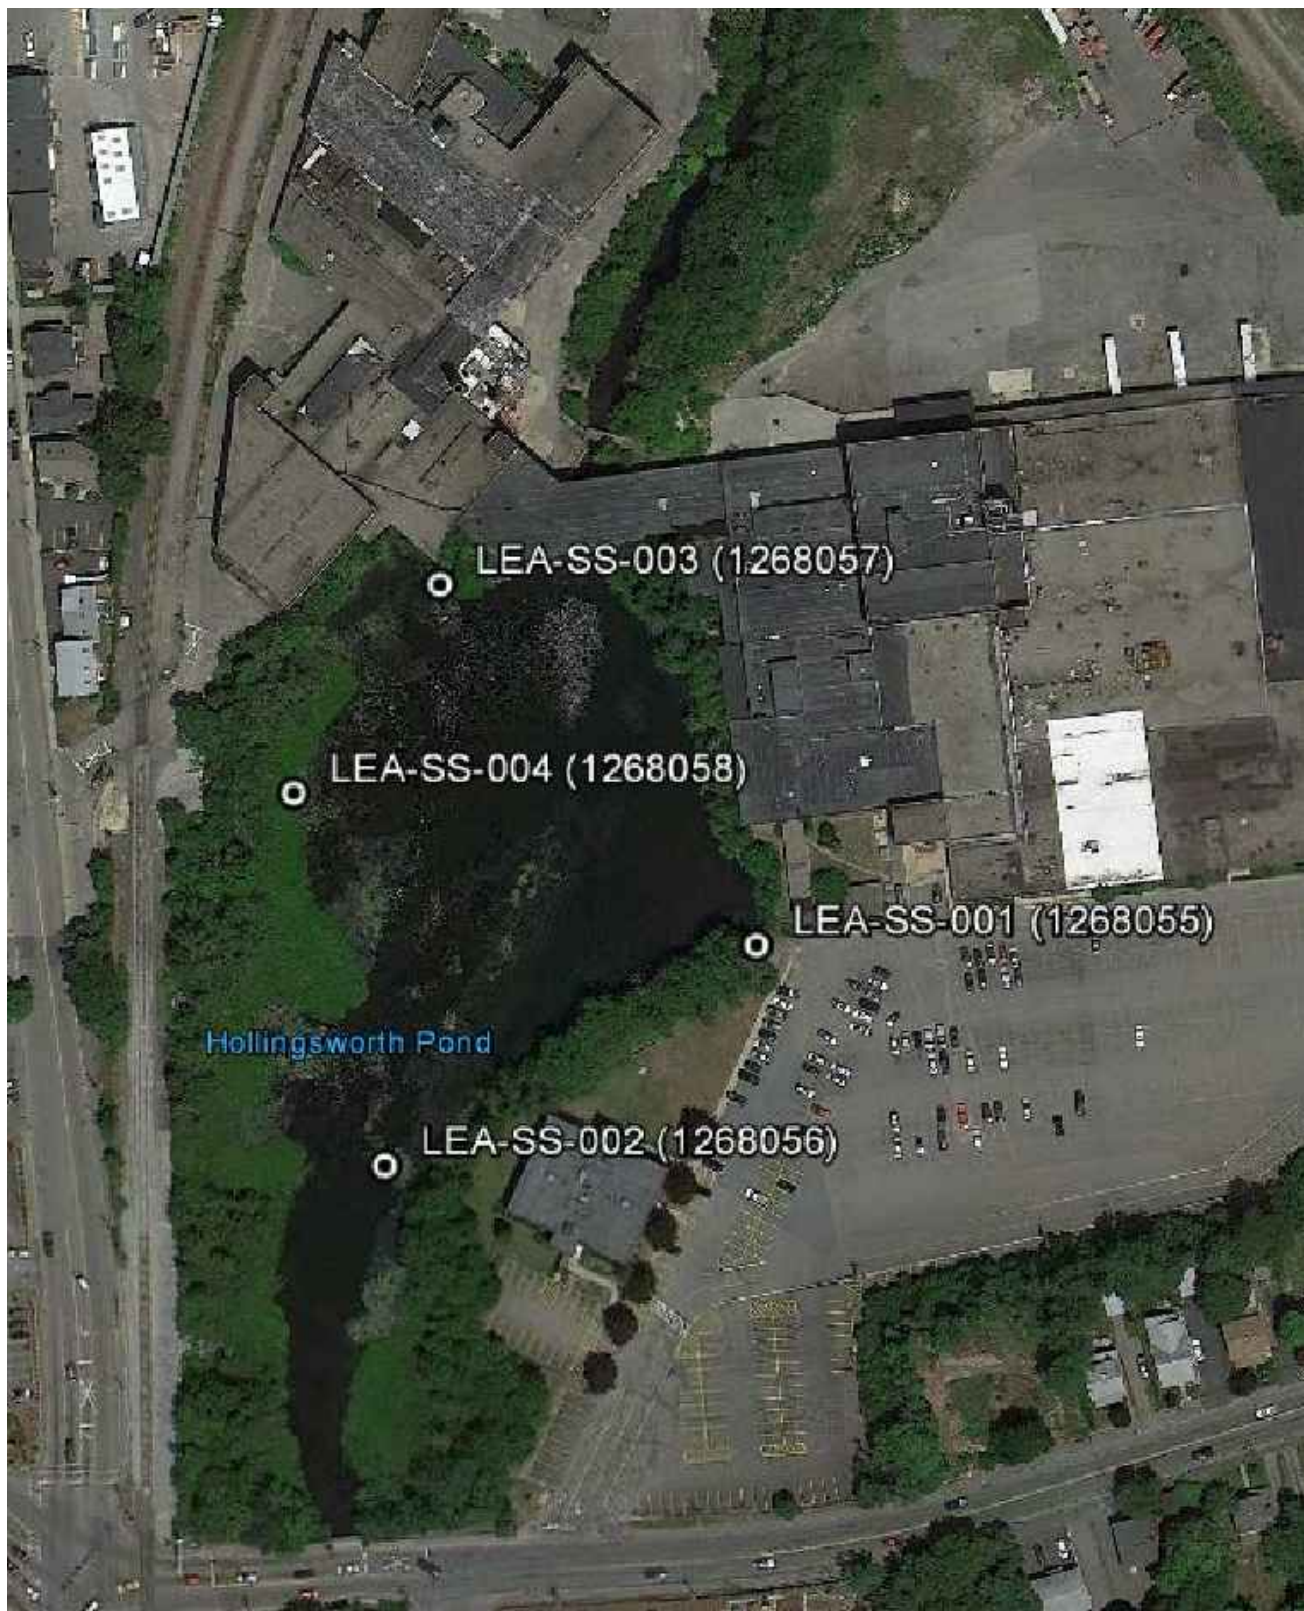
MAP IMAGE OBTAINED FROM GOOGLE EARTH,  
NOVEMBER 5, 2011. DATE OF IMAGERY JUNE 10, 2012.

The samples were distributed spatially to capture areas within the pond with sediments that would be exposed or mobilized if the dam was removed and to gather representative information regarding the sediment conditions:

The samples were collected in water depths of 1.25 feet to 3 feet, and ranged from 2 inches to 3.83 feet below ground surface. Predominantly the sediment observed was dark brown/black silty-fine to medium sand with trace gravel. Sample location LEA-SS-003 had a notable petroleum odor at collection and a sheen was observed in the area.
