TECHNICAL MEMORANDUM

November 8, 2024

**RE: Town-Wide Culvert Assessment
Town of Braintree, MA**

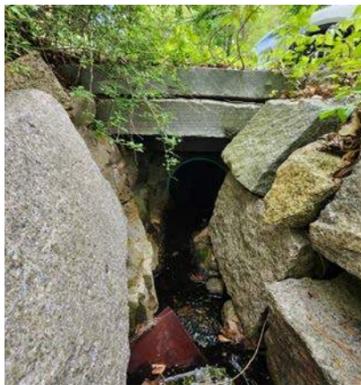
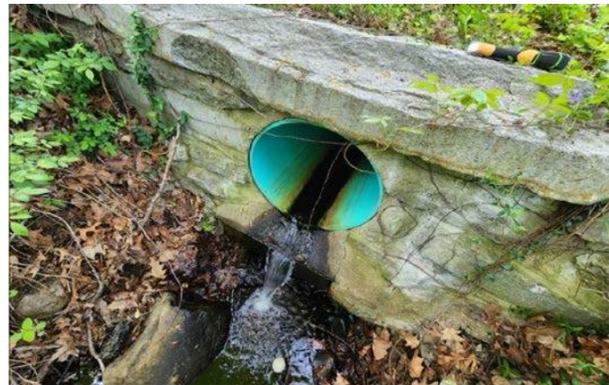
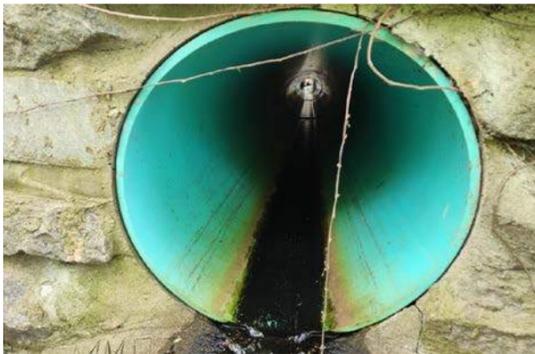
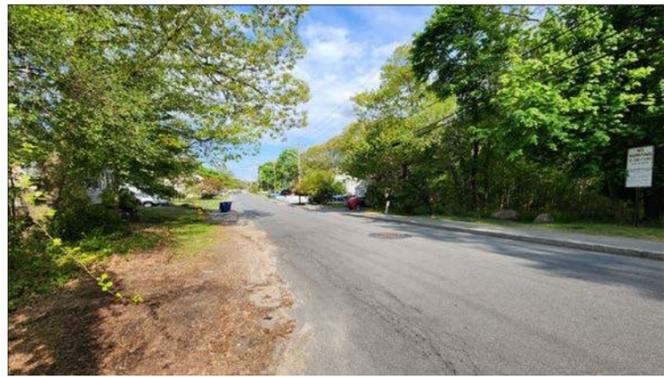
Overall Condition Ratings	
Culvert:	2
Slope Stability:	3
Surface:	1
Maintenance:	1

Additional Notes
Newer culvert, water flowing correctly, surface looks good, sized correctly.

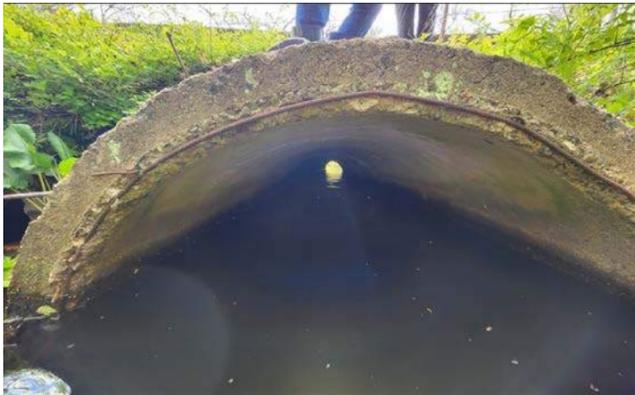
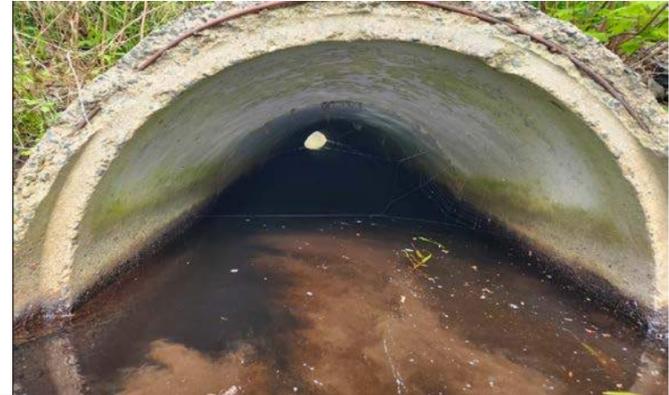
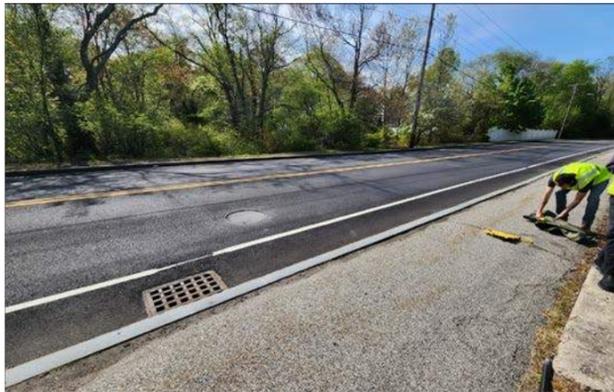
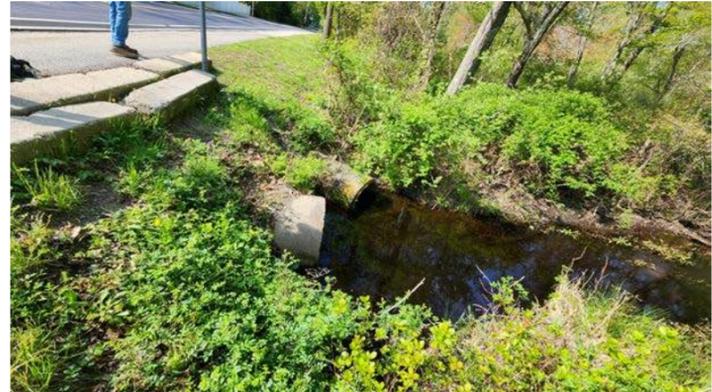
Additional Notes
<p>Culvert showing deterioration and exposed rebar. Pipe half full of stagnant water, seemingly no slope. Sediment level is high. Could use some maintenance of the waterway and surrounding slopes, erosion clearly visible.</p>

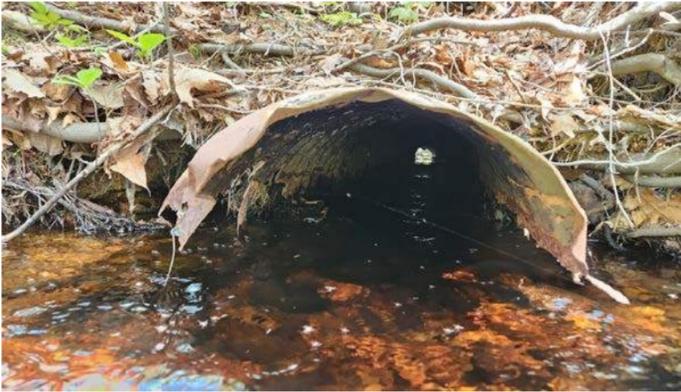
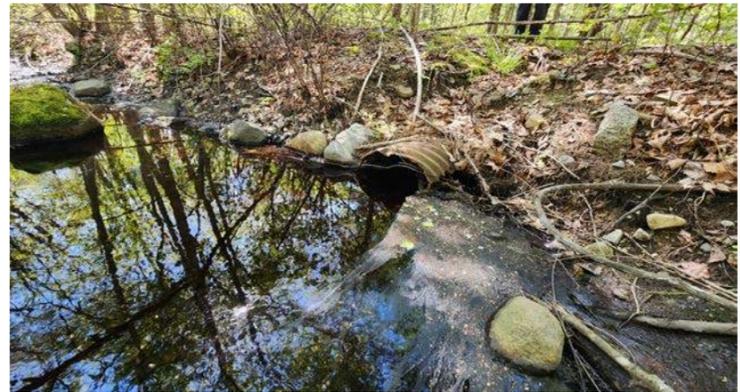
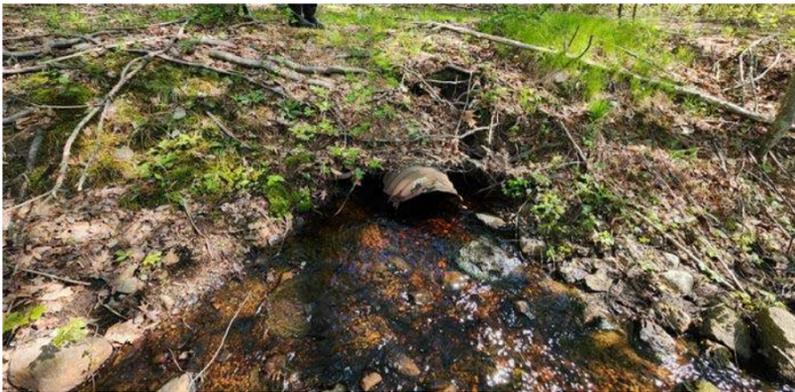
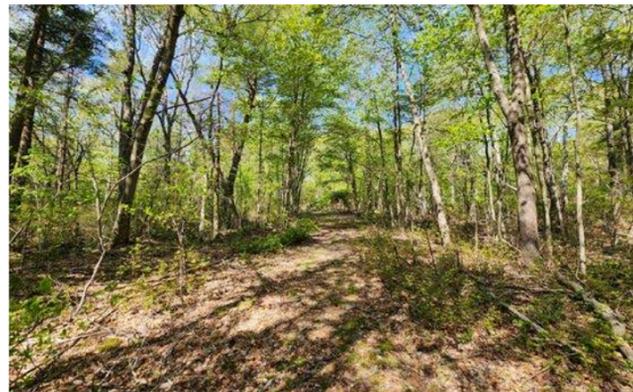
- **Culvert #4 – 18” CMP Culvert under Trail/Easement near Claire St:** The existing 18” CMP culvert is severely corroded and missing a bottom. In addition, it is undersized. We recommend demolishing the culvert and daylighting the stream if there are no conflicting utilities present.

Additional Notes
Culvert accessed from trail starting at end of St. Claire Circle. Culvert itself is almost fully deteriorated and needs to be replaced. Very undersized for how much water would come through in a 100 year storm. Trail and backyards (possibly basements) would be flooded.

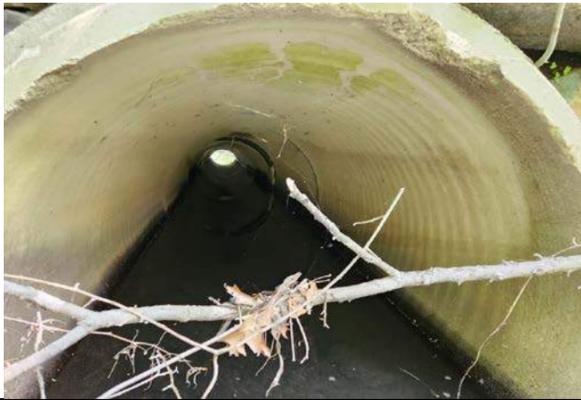
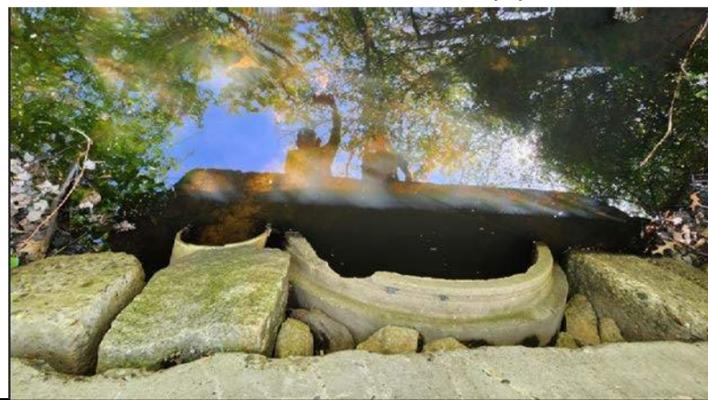
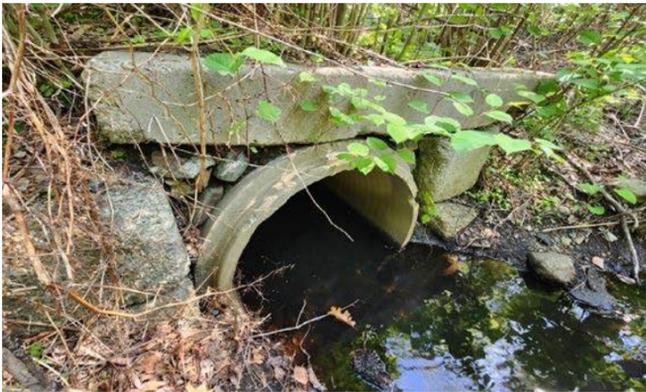
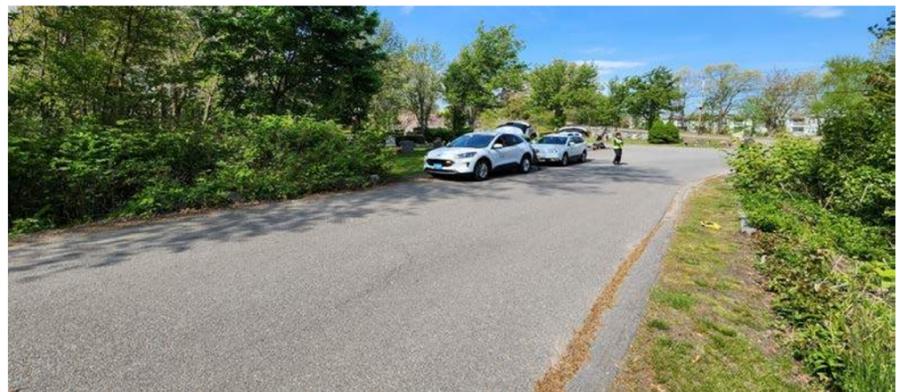
Additional Notes
Culvert showing only minor wear. The streambed and surrounding basin area leave room for some flooding conditions.

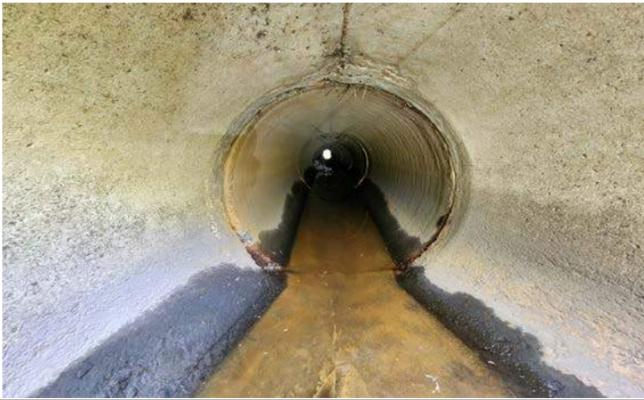
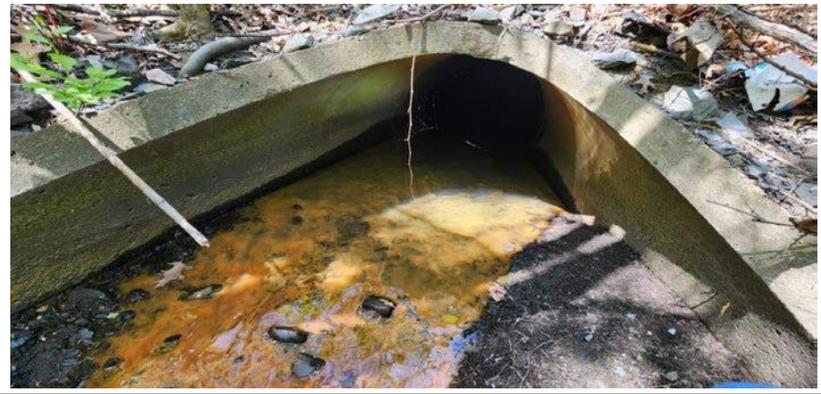
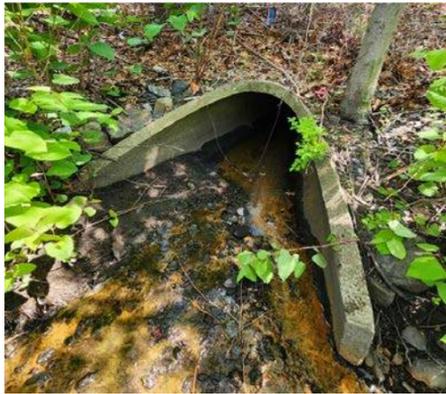
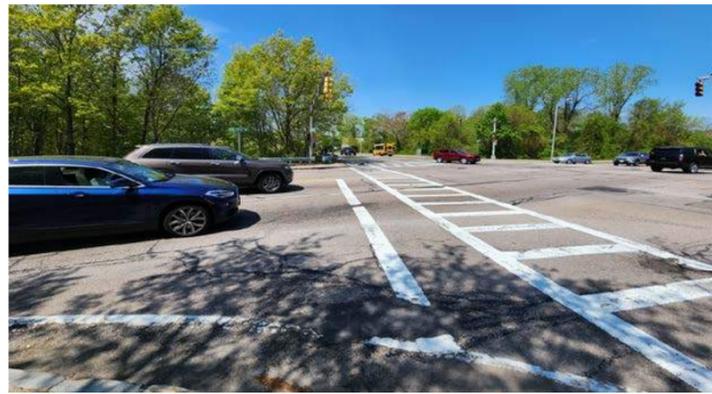
Additional Notes
Trash and overgrowth on Inlet and Outlet side. Biological growth in water. Needs a clean up. The streambed and surrounding basin area leave room for some flooding conditions.

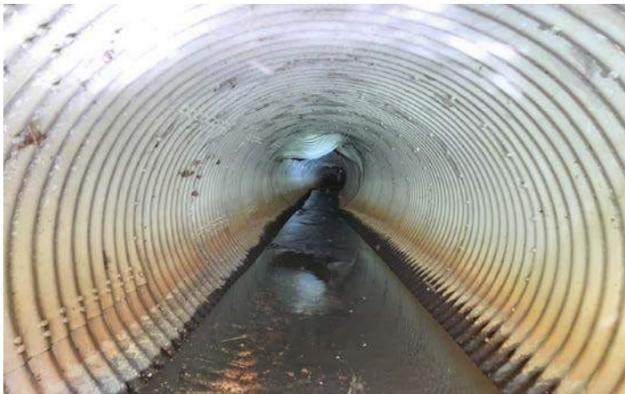
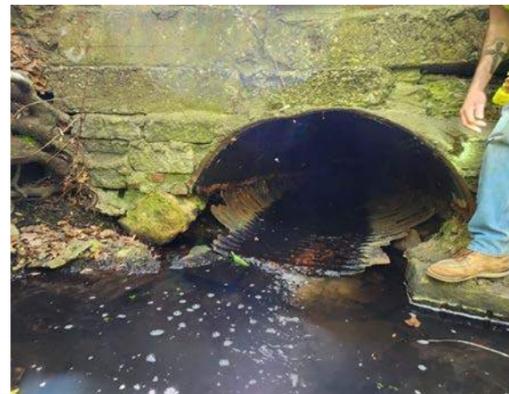
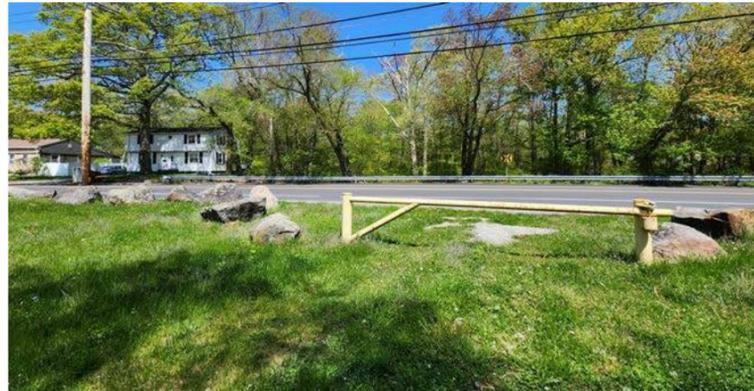
Additional Notes
Culvert pipe is in bad condition, incoming pipe penetration needs to be investigated, looks like it's from sewer? Erosion present. Cement blocks near inlet side could block culvert if they slide.

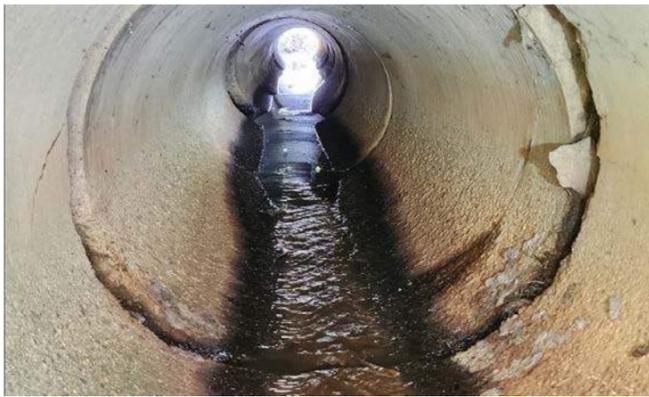
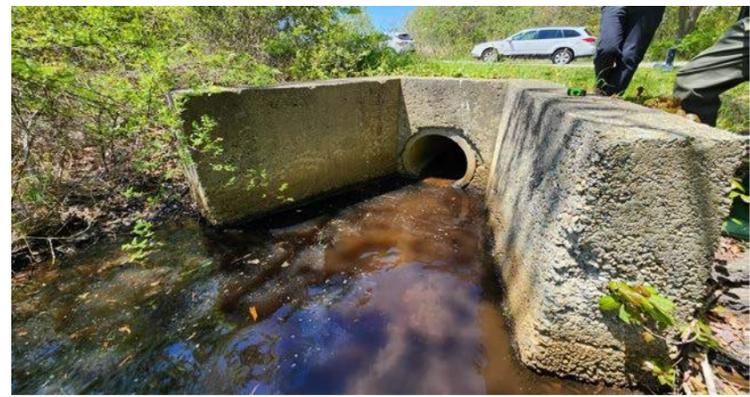
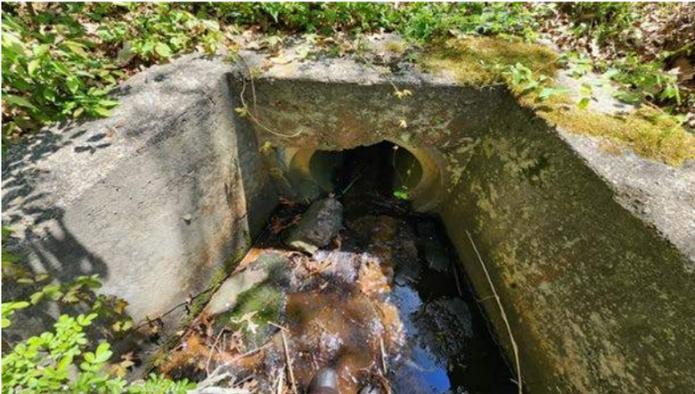
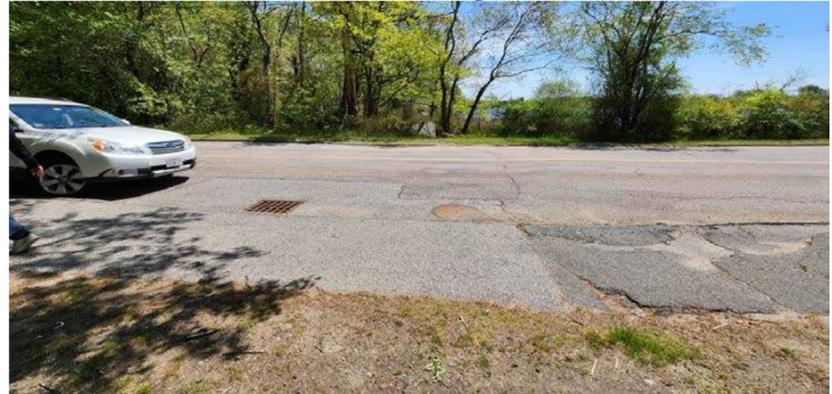
Joints along culvert are separated with roots and soil infiltration. Needs cleanup/maintenance. Sunset lake and basin appear to be able to handle flooding but in a bad storm it could be too much for the size of the culvert.

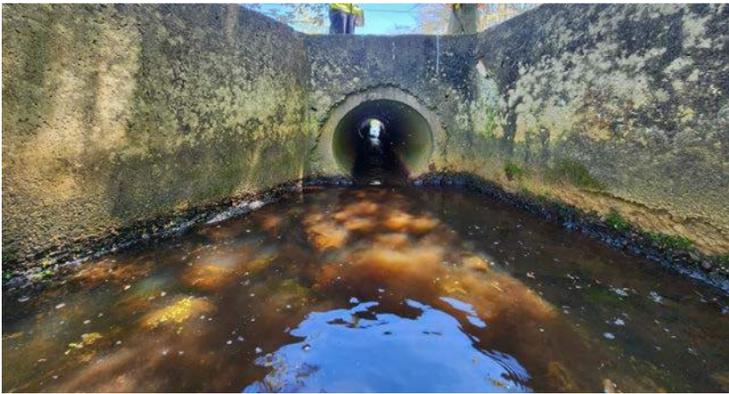
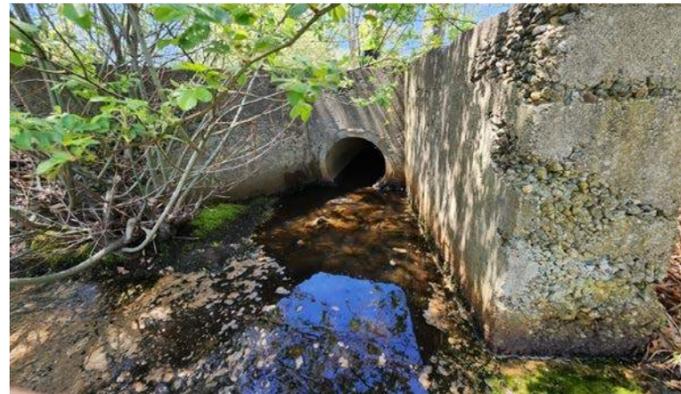
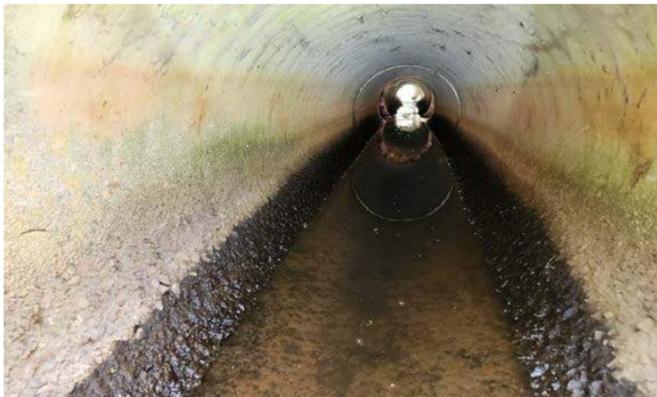
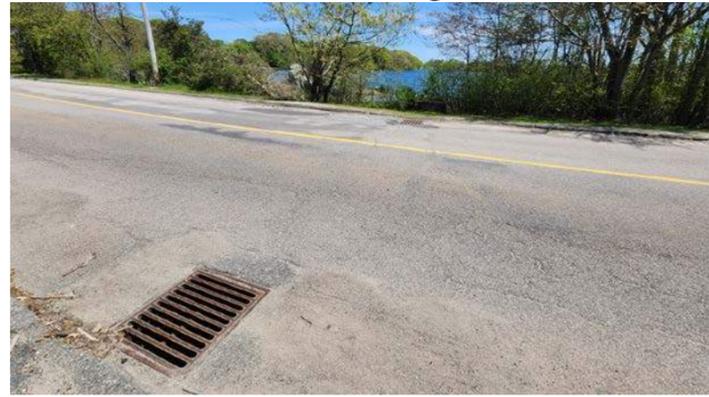
Additional Notes
Soil has settled around the culvert and the roadway is cracking. Road could be repaved. Culvert in fine condition.

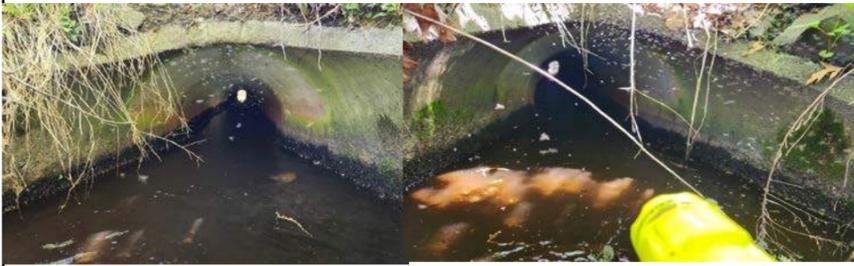
Additional Notes
Erosion of embankment on inlet side. Both sides a bit overgrown. Flooding possible due to undersized culverts, could flood nearby yards and possibly basements.

Inside of culvert at inlet (Barrel A-right, Barrel B - Left)

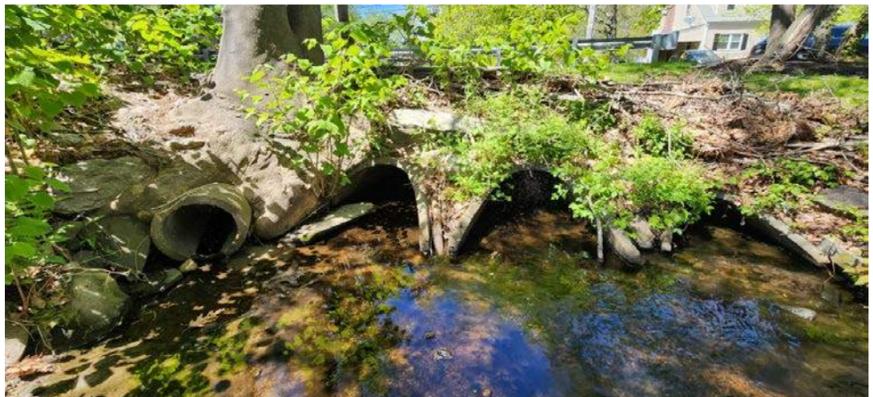
Culvert at outlet

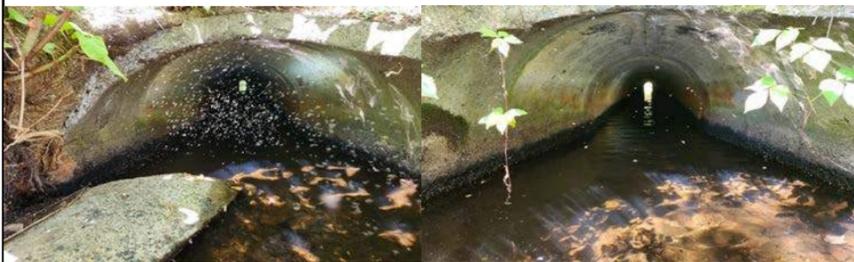
Inside of culvert at outlet (Barrel A-left, Barrel B-right)

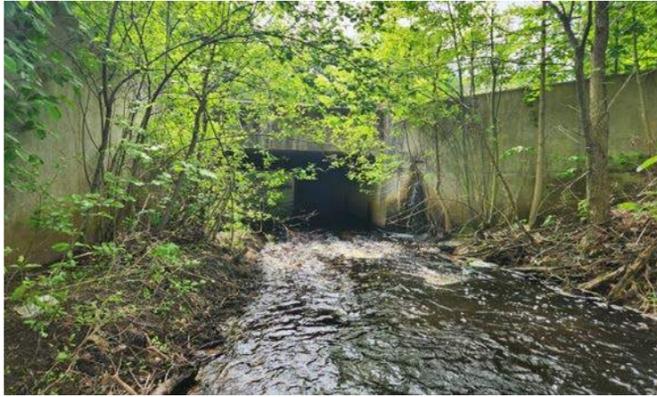
Inlet	Notes
Material (Concrete, Stone, Masonry, etc.): Concrete	<i>ex: Cracking, Settlement, Scouring, Evidence of Flooding, etc.</i> Bottom of culvert buried, cannot determine depth of sediment. Slight loss of mortar in joint between headwall and wingwall.
Headwall? (Y/N): Y	
Wingwalls? (Y/N): Y	
Bed Material (Stone, Sand, Mud, etc.): Stone	
Depth of Water from Invert (in): 8	
Grate? (Y/N): N

Additional Notes
Culvert in good conditions and well sized.

Culvert at inlet

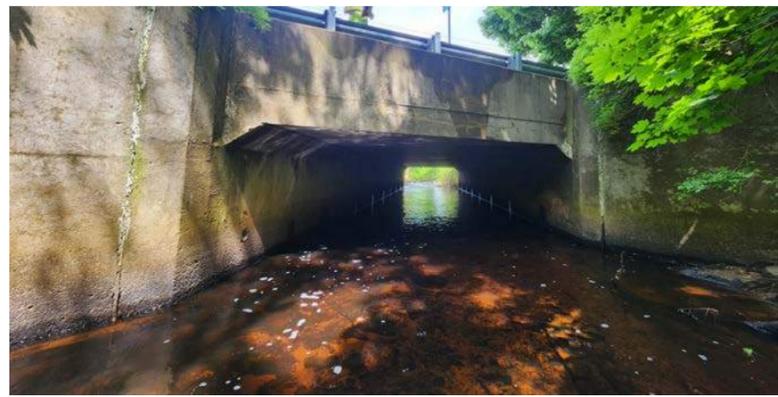
Outlet	Notes
Material (Concrete, Stone, Masonry, etc.): Concrete	<i>ex: Cracking, Settlement, Scouring, Evidence of Flooding, etc.</i> Bottom of culvert buried, cannot determine depth of sediment. Slight loss of mortar in joint between headwall and wingwall.
Headwall? (Y/N): Y	
Wingwalls? (Y/N): Y	
Bed Material (Stone, Sand, Mud, etc.): Stone	
Depth of Water from Invert (in): 7	
Grate? (Y/N): N

Culvert at outlet

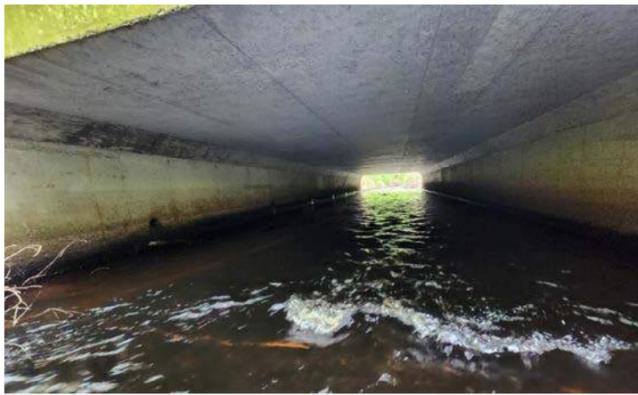
Inlet	Notes
Material (Concrete, Stone, Masonry, etc.): Concrete	<i>ex: Cracking, Settlement, Scouring, Evidence of Flooding, etc.</i> GPS point was taken at right side facing inlet. There is no caulk/mortar at joints between headwall and wingwall (some separation).
Headwall? (Y/N): Y	
Wingwalls? (Y/N): Y	
Bed Material (Stone, Sand, Mud, etc.): Sand & mud	
Depth of Water from Invert (in): 4.5	
Grate? (Y/N): N

Inside of culvert at inlet

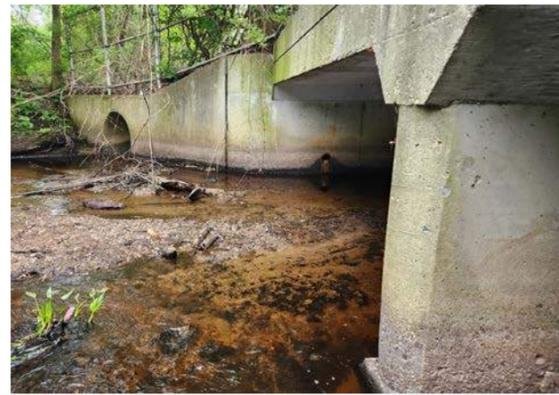
Outlet	Notes
Material (Concrete, Stone, Masonry, etc.): Concrete	<i>ex: Cracking, Settlement, Scouring, Evidence of Flooding, etc.</i> Left side has more sediment fill than right. Dept of water from invert is 6" on right side. Depth of sediment from invert is about 6" on left, 0" on right. GPS point was taken at right side facing outlet. There is no caulk/mortar at joints between headwall and wingwall (some separation).
Headwall? (Y/N): Y	
Wingwalls? (Y/N): Y	
Bed Material (Stone, Sand, Mud, etc.): Sand & mud	
Depth of Water from Invert (in): 6	
Grate? (Y/N): N

Culvert at outlet

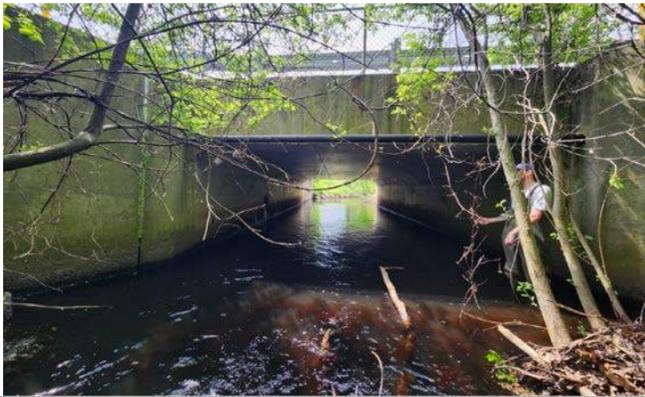
Inlet	Notes
Material (Concrete, Stone, Masonry, etc.): Concrete	<i>ex: Cracking, Settlement, Scouring, Evidence of Flooding, etc.</i> Pipe service crossing river at headwall. Some caulk/mortar at joints between headwall and wingwall worn away.
Headwall? (Y/N): Y	
Wingwalls? (Y/N): Y	
Bed Material (Stone, Sand, Mud, etc.): Stone	
Depth of Water from Invert (in): 21	
Grate? (Y/N): N

Culvert at inlet

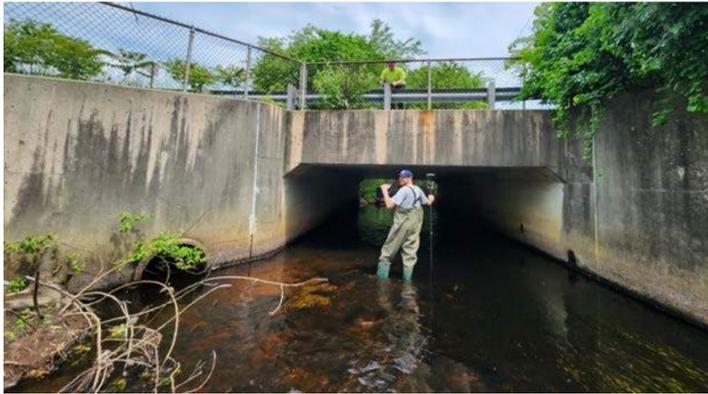
Outlet	Notes
Material (Concrete, Stone, Masonry, etc.): Concrete	<i>ex: Cracking, Settlement, Scouring, Evidence of Flooding, etc.</i> Some caulk/mortar at joints between headwall and wingwall worn away.
Headwall? (Y/N): Y	
Wingwalls? (Y/N): Y	
Bed Material (Stone, Sand, Mud, etc.): Stone	
Depth of Water from Invert (in): 15	
Grate? (Y/N): N

Culvert at outlet

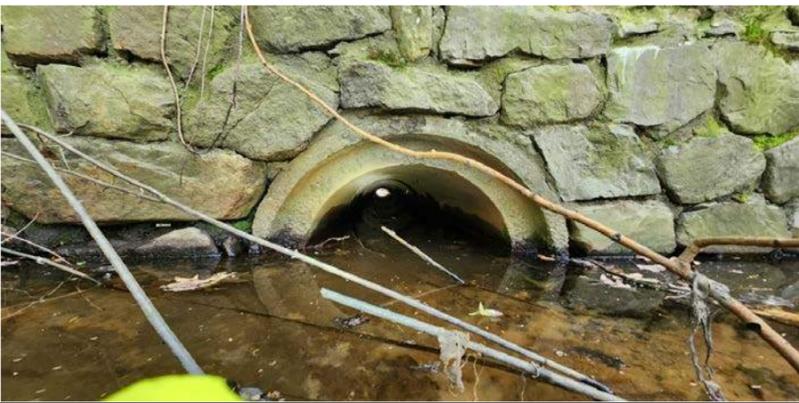
Inlet	Notes
Material (Concrete, Stone, Masonry, etc.): Stone masonry	<i>ex: Cracking, Settlement, Scouring, Evidence of Flooding, etc.</i> Some minor cracking, and some mortar is chipping. Wingwalls are perpendicular off of headwalls.
Headwall? (Y/N): Y	
Wingwalls? (Y/N): Y	
Bed Material (Stone, Sand, Mud, etc.): Mud	
Depth of Water from Invert (in): 12	
Grate? (Y/N): N

Additional Notes
Waterway needs to be cleaned up, culvert has branches in it and culvert is almost full.

Culvert at inlet

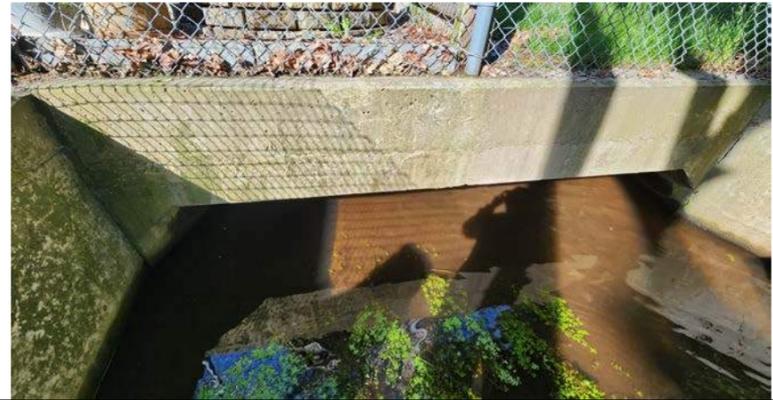
Additional Notes
Needs maintenance, lots of erosion on outlet side causing a large layer of muck at bottom of waterway. Culvert well sized and in good shape.

Outlet of culvert

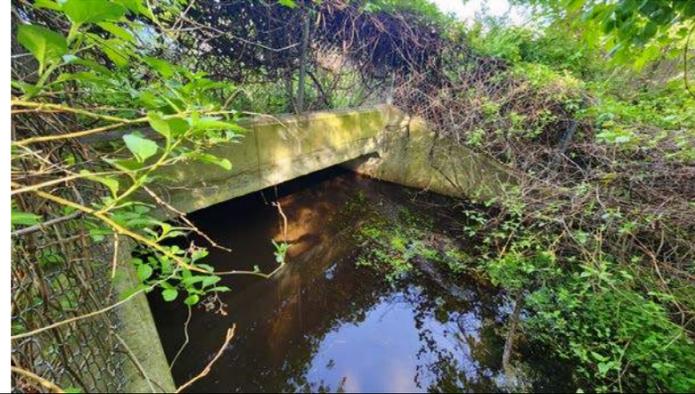
Additional Notes
Needs maintenance, erosion and overgrowth causing a large layer of muck at bottom of waterway. Culvert well sized and in good shape.

Outlet of culvert

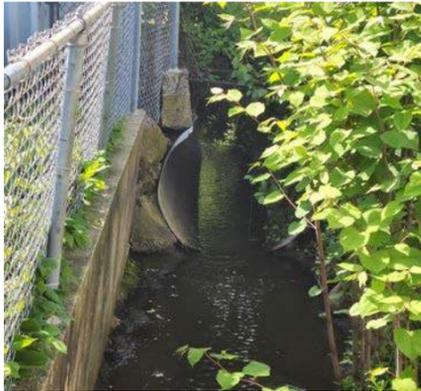
Corrugated metal pipe by inlet

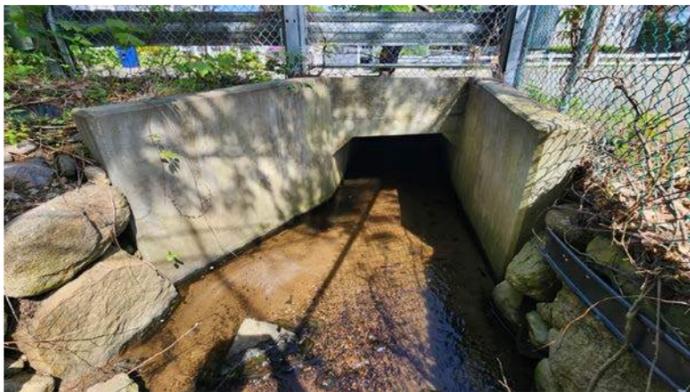
Culvert at inlet

Culvert	Notes
Material (Concrete, Stone, Brick, Metal, etc.): CMP	<i>ex: Blockage, Deformation, Cracking, Corrosion, etc.</i> Roof of culvert is collapsing. Lots of deformation of metal throughout the culvert length. Rocks inside of culvert. Culvert alignment bends halfway down, sagging occurs there. Town recently trimmed back bushes. Requires a lot of maintenance. Very narrow stream channel with banks at risk for erosion into channel.
Shape (Round, Elliptical, Box, Arch, etc.): Round	
Width/Diameter (in): 48	
Height (in): N/A	
Length (ft): N/A	
Number of Barrels: 1	
Span (ft): N/A

Inlet	Notes
Material (Concrete, Stone, Masonry, etc.): Concrete/Stone	<i>ex: Cracking, Settlement, Scouring, Evidence of Flooding, etc.</i> Wingwalls are damaged (separation from road, cracking).
Headwall? (Y/N): N	
Wingwalls? (Y/N): Y	
Bed Material (Stone, Sand, Mud, etc.): Stone	
Depth of Water from Invert (in): 7	
Grate? (Y/N): N

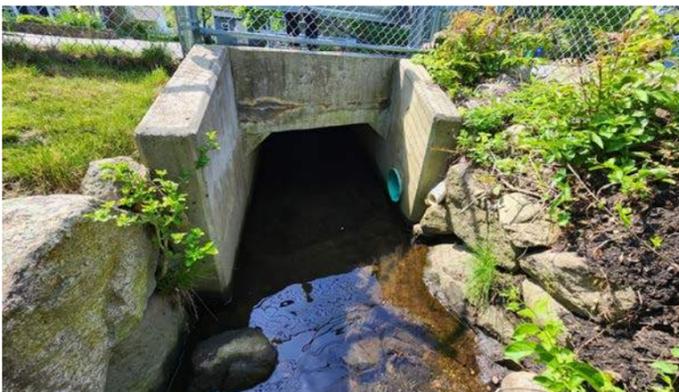
Culvert at outlet

Outlet	Notes
Material (Concrete, Stone, Masonry, etc.): N/A	<i>ex: Cracking, Settlement, Scouring, Evidence of Flooding, etc.</i> Highly overgrown vegetation at outlet. Pipe is squished/deformed down at outlet.
Headwall? (Y/N): N	
Wingwalls? (Y/N): N	
Bed Material (Stone, Sand, Mud, etc.): Stone	
Depth of Water from Invert (in): 4	
Grate? (Y/N): N

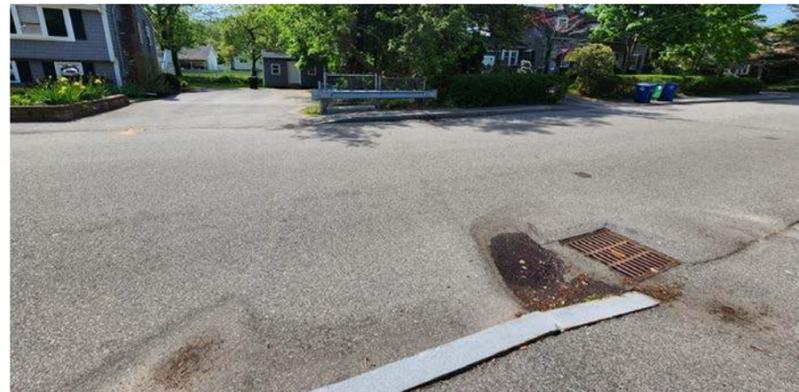
Site surface facing inlet

Surface	Notes
Surface Type (Paved, Gravel, Dirt, etc.): Paved	<i>ex: Pavement Cracking, Potholes, Sinkholes, Guardrail Damage, etc.</i> Pavement is sagging, cracked, and chunks are missing. Wooden guardrail present.
Guardrail Present? (Y/N): Y

Additional Notes
Requires a lot of maintenance. Very narrow stream channel with banks at risk for erosion into channel. Culvert pipe in rough shape, roadway in very poor condition.

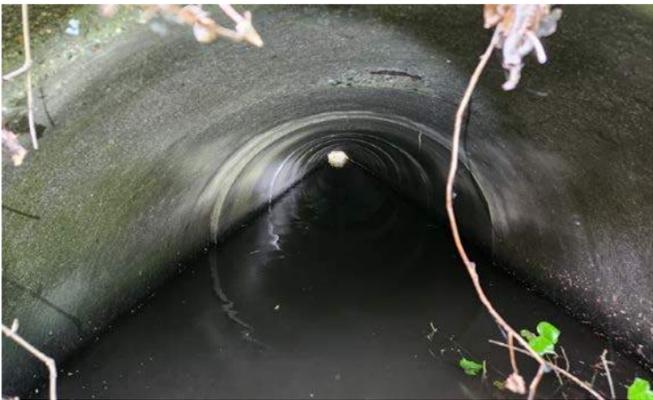
Inside of culvert at inlet

Culvert	Notes
Material (Concrete, Stone, Brick, Metal, etc.): Concrete	<i>ex: Blockage, Deformation, Cracking, Corrosion, etc.</i> Culvert diameter is smaller on outlet end than inlet. Could restrict flow. Otherwise in good condition. Headwalls or wingwalls would help with surrounding ground erosion if added. Garbage in outlet area.
Shape (Round, Elliptical, Box, Arch, etc.): Round	
Width/Diameter (in): 42 (inlet), 37 (outlet)	
Height (in): N/A	
Length (ft): N/A	
Number of Barrels: 1	
Span (ft): N/A

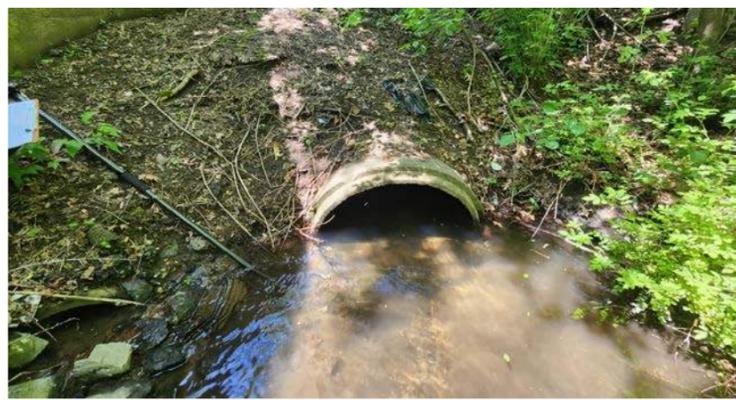
Culvert at outlet

Outlet	Notes
Material (Concrete, Stone, Masonry, etc.): Concrete	<i>ex: Cracking, Settlement, Scouring, Evidence of Flooding, etc.</i> Lack of headwall causing erosion of soil around outlet. Almost half full with sediment.
Headwall? (Y/N): N	
Wingwalls? (Y/N): N	
Bed Material (Stone, Sand, Mud, etc.): Stone, sand, silt	
Depth of Water from Invert (in): 12	
Grate? (Y/N): N

Additional Notes
Cleanup maintenance needed, trash on outlet side and inlet side overgrown. Erosion present.

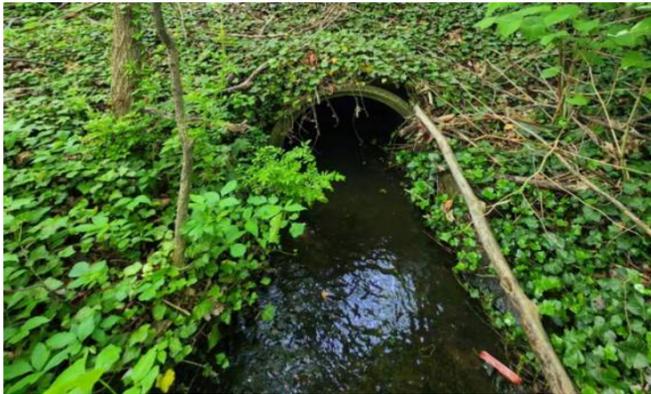
Culvert at inlet

Inlet	Notes
Material (Concrete, Stone, Masonry, etc.): Concrete	<i>ex: Cracking, Settlement, Scouring, Evidence of Flooding, etc.</i> Highly overgrown with vegetation at inlet. Lack of headwall causing some erosion of soil and vegetation around inlet.
Headwall? (Y/N): N	
Wingwalls? (Y/N): N	
Bed Material (Stone, Sand, Mud, etc.): Stone	
Depth of Water from Invert (in): 6	
Grate? (Y/N): N

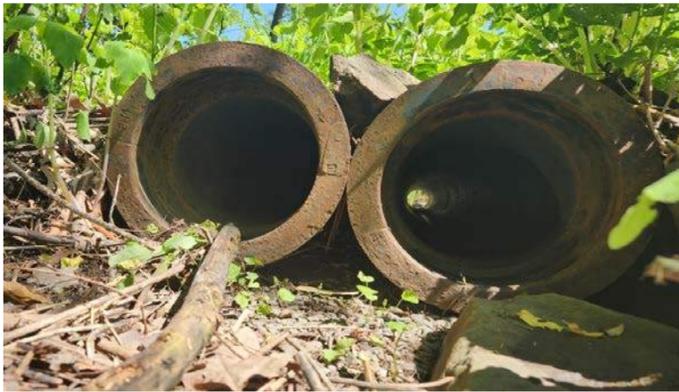
Culvert at inlet

Culvert	Notes
Material (Concrete, Stone, Brick, Metal, etc.): Cast iron	<i>ex: Blockage, Deformation, Cracking, Corrosion, etc.</i> Metal pipes, some light corrosion, but looks like this culvert has not seen water in a while. Slightly perched.
Shape (Round, Elliptical, Box, Arch, etc.): Round	
Width/Diameter (in): 8	
Height (in): N/A	
Length (ft): 19'-3"	
Number of Barrels: 2	
Span (ft): 2 (inlet); 1.5 (outlet)

Inlet	Notes
Material (Concrete, Stone, Masonry, etc.): N/A	<i>ex: Cracking, Settlement, Scouring, Evidence of Flooding, etc.</i> Rocks/soil somewhat supporting culvert.
Headwall? (Y/N): N	
Wingwalls? (Y/N): N	
Bed Material (Stone, Sand, Mud, etc.): Stone	
Depth of Water from Invert (in): 0	
Grate? (Y/N): N

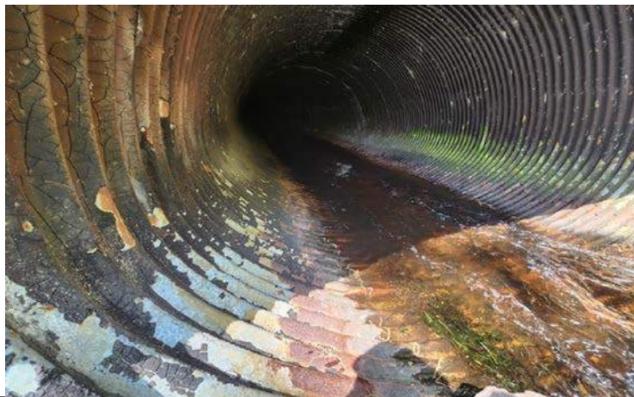
Inside of culvert at inlet

Additional Notes
Culvert pipe is corroding. Otherwise no issues and sized correctly.

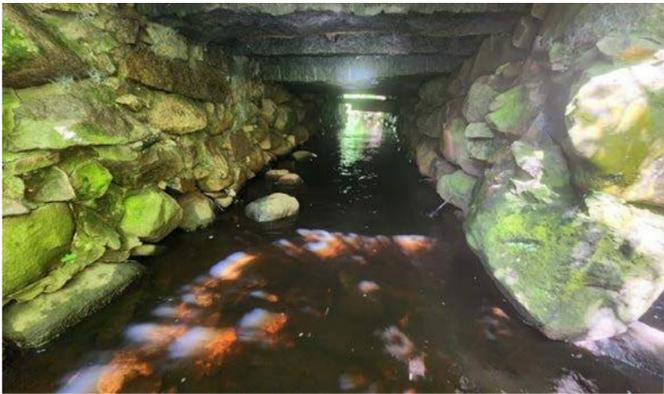
Culvert at inlet

Additional Notes
Utility pipe going across the culvert width in the culvert on the outlet side. Wood planks surrounding the utility pipe. Culvert showing clear signs of age and should be replaced. Sinkholes present off the edges of the road along the culvert alignment.

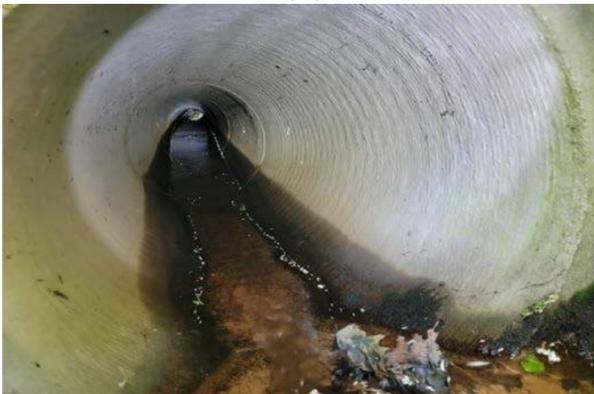
Inside of pipe at inlet

Additional Notes
Culvert has branches and dirt built up in the pipe and at the inlet side, needs to be cleaned out.

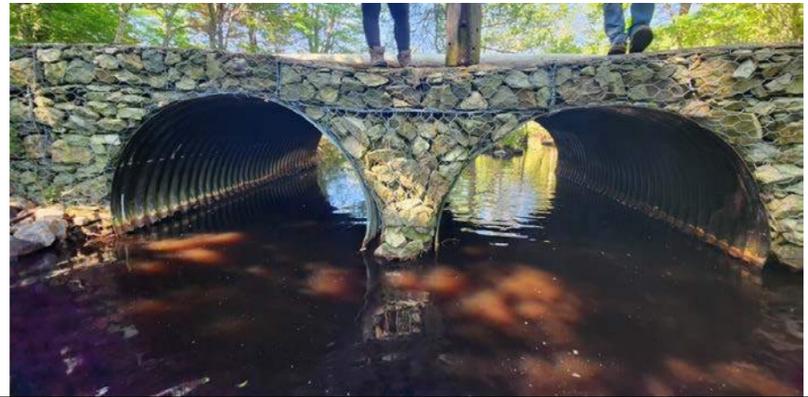
Culvert at outlet

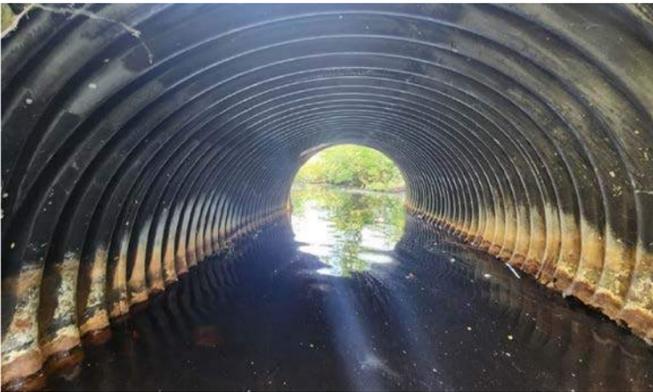
Inside of culvert at inlet

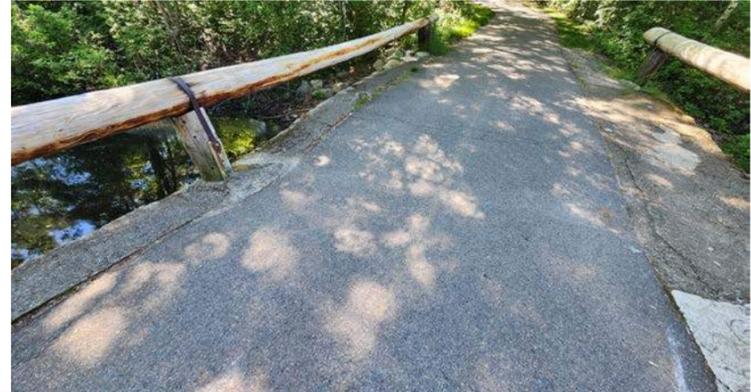
Site surface

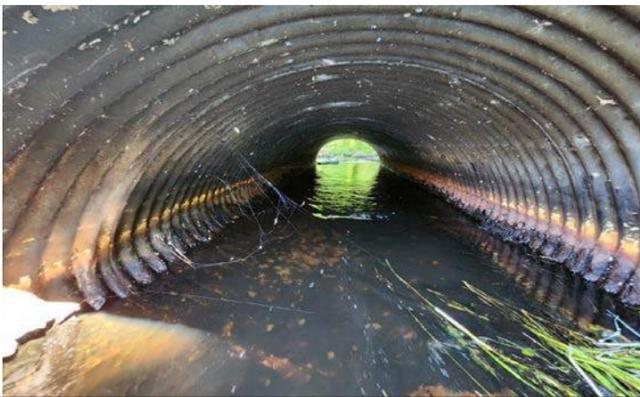
Culvert	Notes
Material (Concrete, Stone, Brick, Metal, etc.): CMP	<i>ex: Blockage, Deformation, Cracking, Corrosion, etc.</i> Bottom heavily corroded. Deformed by weight of headwalls and trail above, more at outlet side. Inlet flow comes from dam. Some branches in stream we cleared out.
Shape (Round, Elliptical, Box, Arch, etc.): Round	
Width/Diameter (in): 52	
Height (in): 42 (inlet) 32 (outlet)	
Length (ft): N/A	
Number of Barrels: 1	
Span (ft): N/A

Inside of culvert at inlet

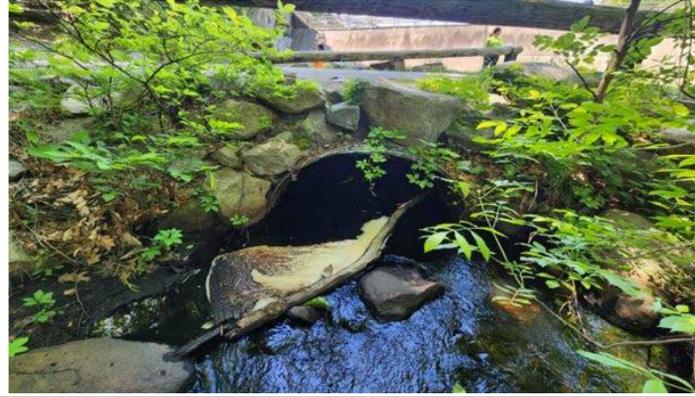
Outlet	Notes
Material (Concrete, Stone, Masonry, etc.): Stone	<i>ex: Cracking, Settlement, Scouring, Evidence of Flooding, etc.</i> Large boulder/stones loosely laid around outlet for support.
Headwall? (Y/N): Y	
Wingwalls? (Y/N): N	
Bed Material (Stone, Sand, Mud, etc.): Stone and muck	
Depth of Water from Invert (in): 6	
Grate? (Y/N): N

Culvert at outlet

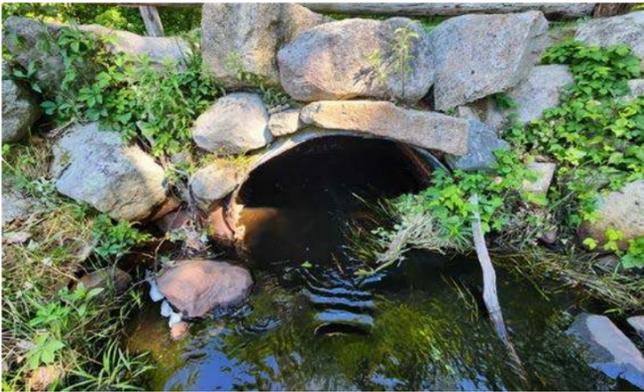
Inlet	Notes
Material (Concrete, Stone, Masonry, etc.): Stone	<i>ex: Cracking, Settlement, Scouring, Evidence of Flooding, etc.</i> Large boulder/stones loosely laid around inlet for support.
Headwall? (Y/N): Y	
Wingwalls? (Y/N): N	
Bed Material (Stone, Sand, Mud, etc.): Stones and muck	
Depth of Water from Invert (in): 9	
Grate? (Y/N): N

Culvert at inlet

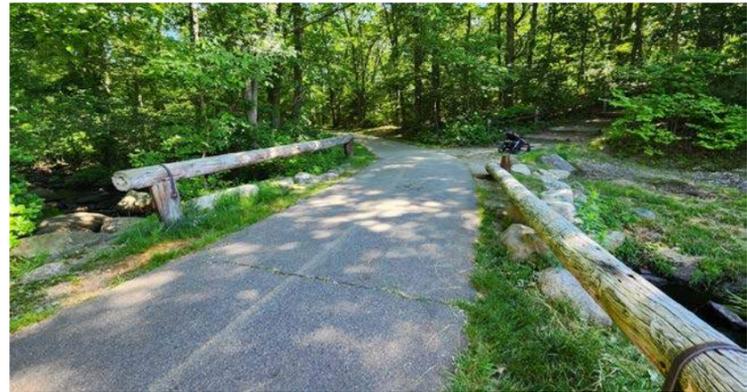
Surface	Notes
Surface Type (Paved, Gravel, Dirt, etc.): Paved	<i>ex: Pavement Cracking, Potholes, Sinkholes, Guardrail Damage, etc.</i> Paved trail in good condition, no sagging. Some cracking could be due to settlement of headwalls and culvert but difficult to tell. Wooden post fence on either side of trail in good condition.
Guardrail Present? (Y/N): Y

Site surface

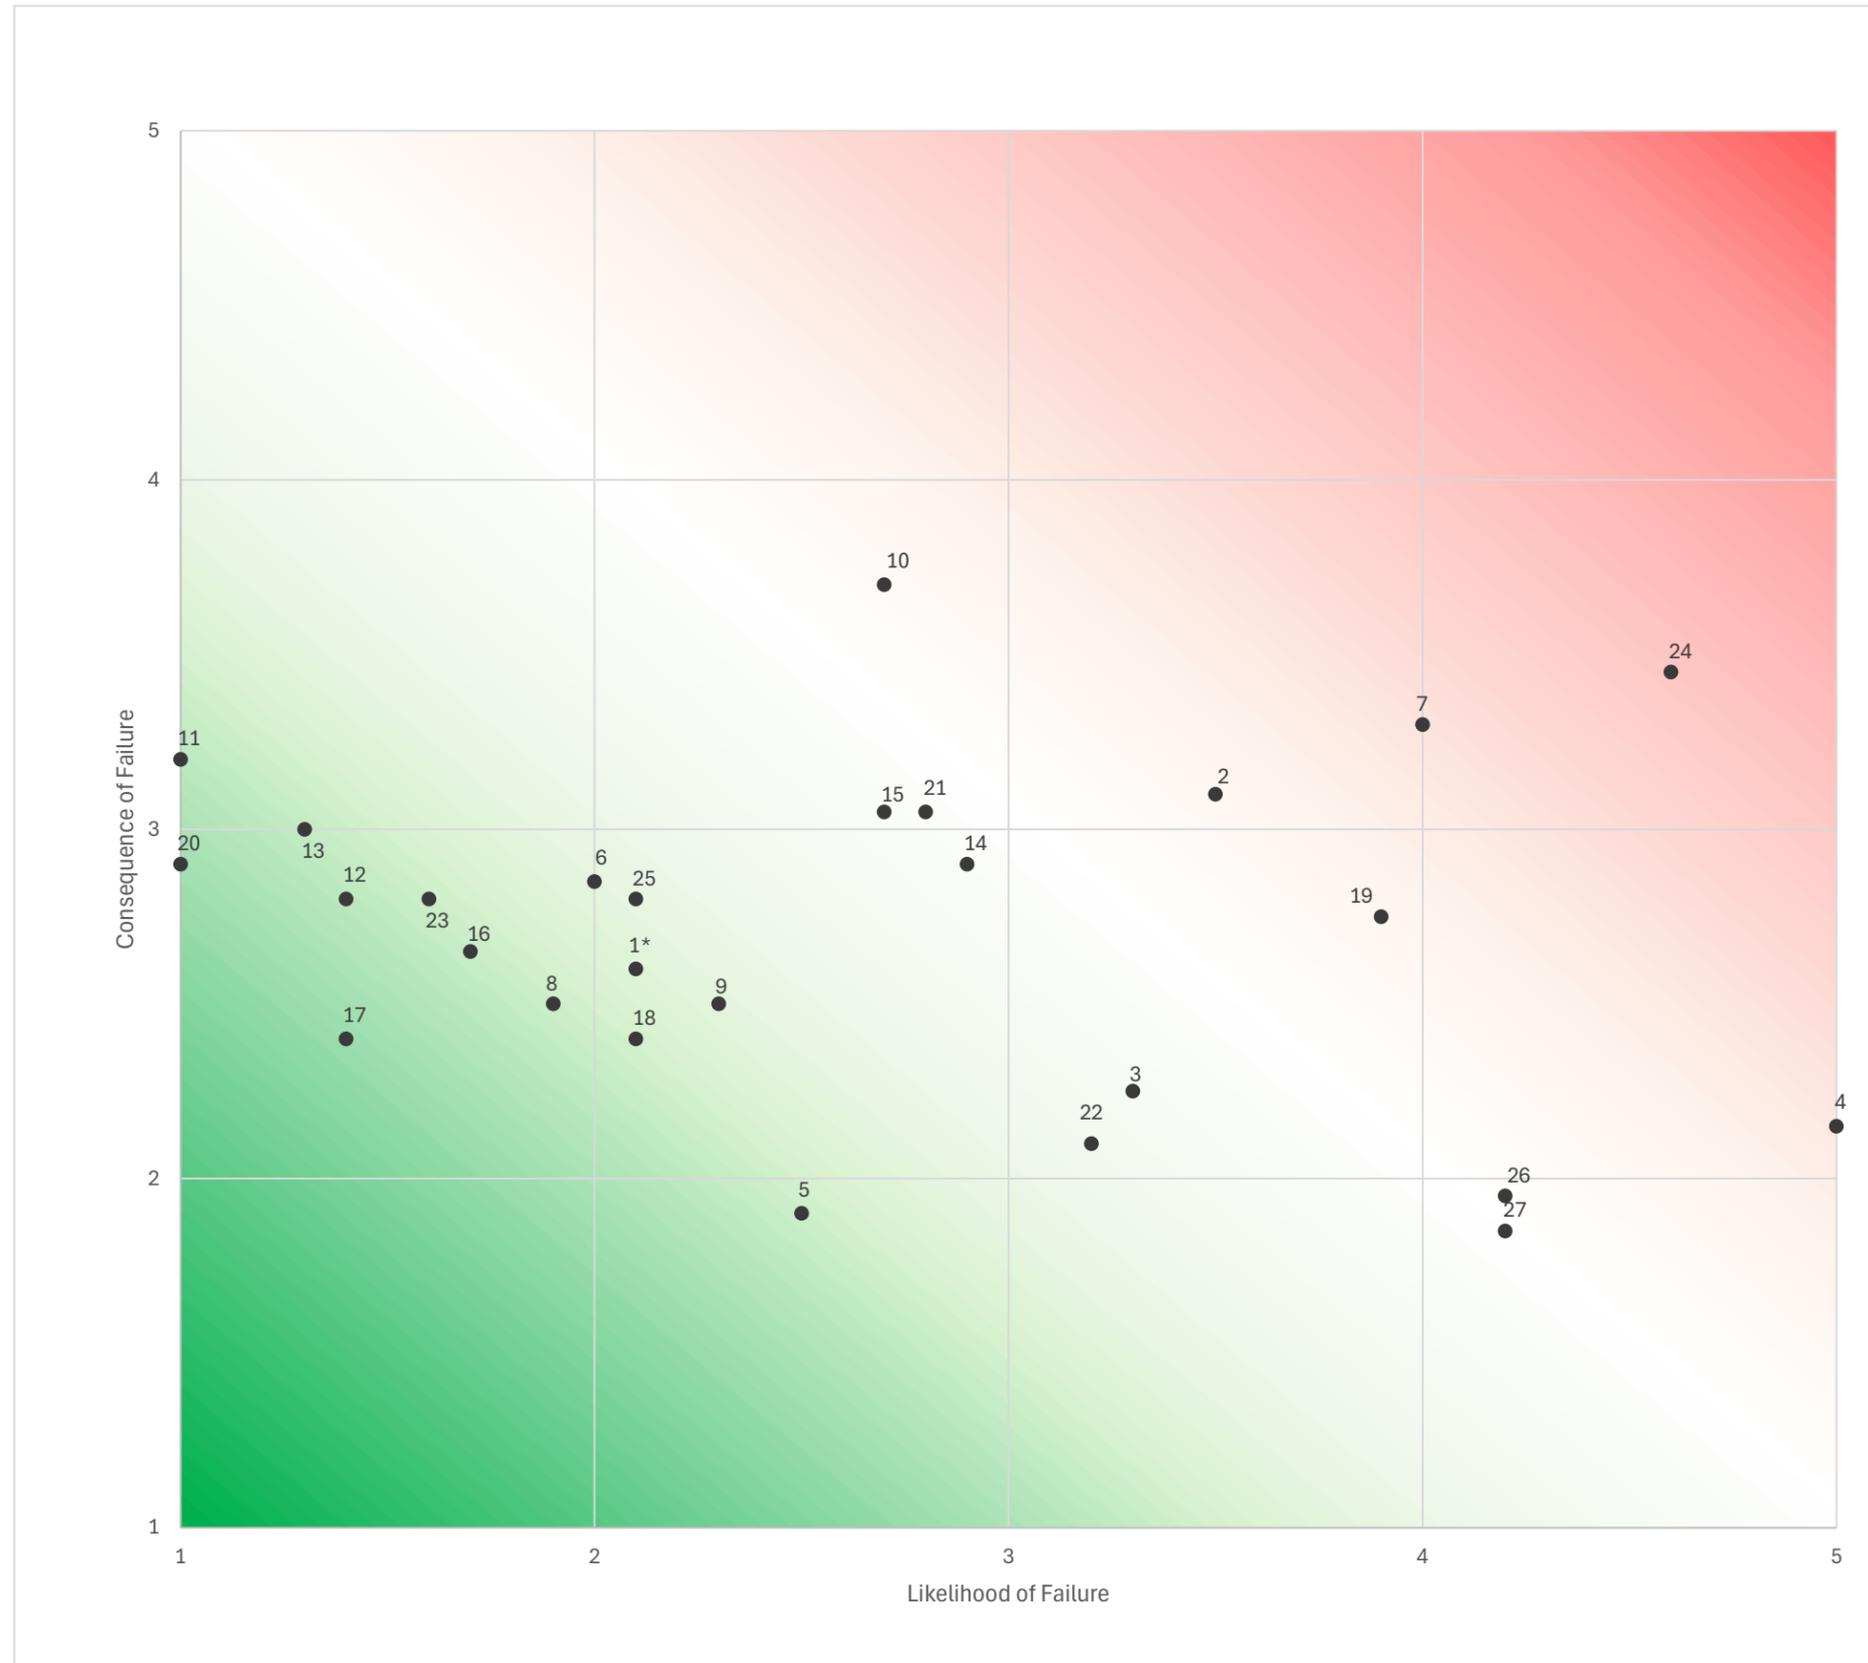
Figure 1. Criticality Analysis

Figure 1 below depicts the criticality analysis in graphical form. Culverts towards the top right of the chart are marked as higher priority based on their criticality.
