TOWN OF BRAINTREE - AFFORDABLE HOUSING STUDY 74/90 POND STREET

EXISTING CONDITIONS FINDINGS

APRIL 11, 2024

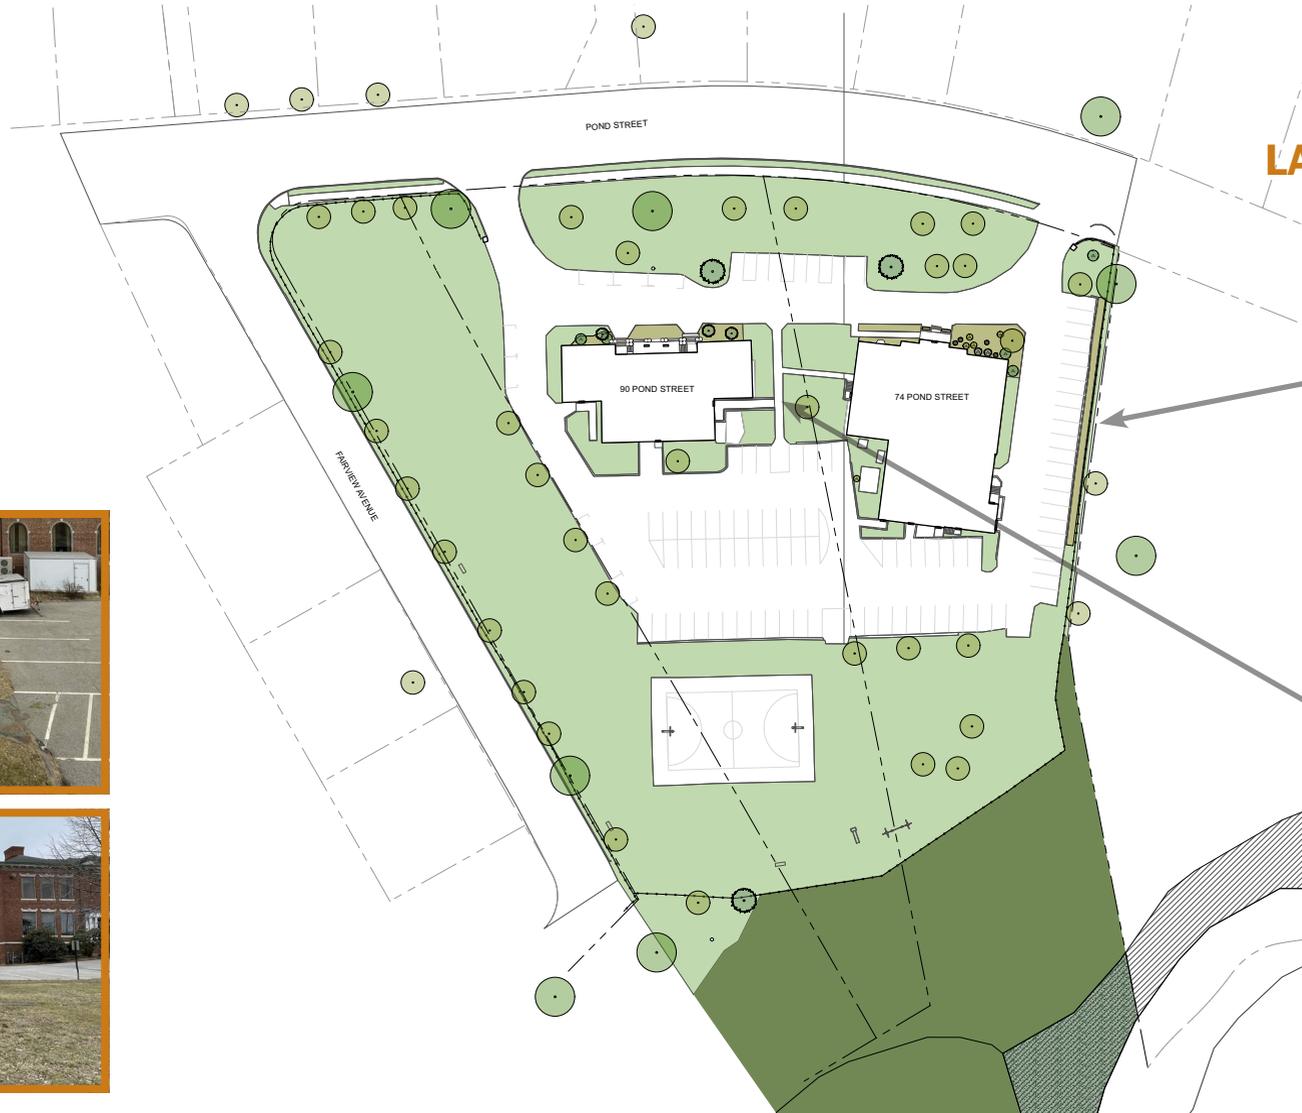
CHAIN LINK FENCE

- » One larger evergreen tree and small oaks, side lawns are open with small oaks.
- » Perimeter along Fairview Ave and Cemetery – chain link fence between the cemetery and the property.
- » **Consider the removal of the fence.**
- » The connection path between two buildings needs shade and screening.

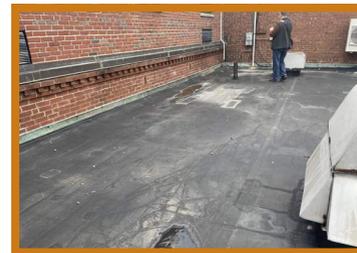
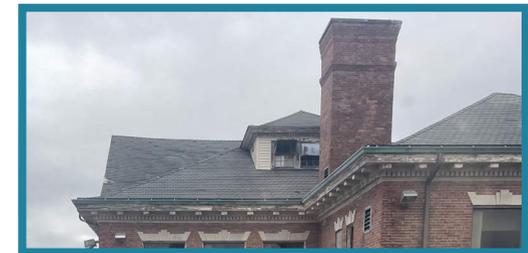
ROOFING - 90

- » Asphalt roofing throughout in poor to fair condition. Access not available. **Replace asphalt shingle & roof flashing. Modify roof insulation as required to meet energy code.**
- » Chimneys appear plumb, some spalling visible. **Repoint both chimneys. Install new fitted caps.**
- » Some damage visible at metal gutter. Existing gutters drain to perimeter drain. **Replace flashing around gutters as required, repair dented gutters & disconnected downspouts.**
- » Painted wood eave trim peeling and visibly damaged. **Replace or repair as required.**

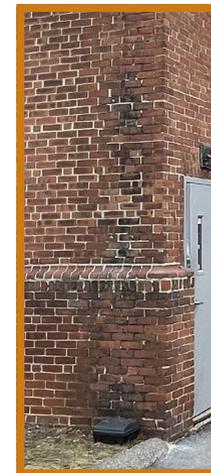
DOORS & WINDOWS - 90

- » Exterior wood window trim is in poor shape, existing steel lintels at lower level are rusted and failing. Stone sills and headers are in decent shape, some cracking visible. Windows are fixed glass units, some broken. Exterior doors have inappropriate hardware. **Replace exterior window trim and window units with operable units. Replace steel lintels, cracked stone sills and headers. Install new door hardware. Reflash & seal openings.**

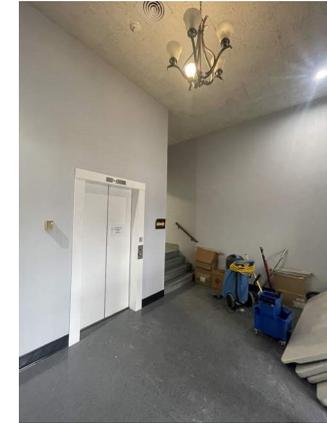
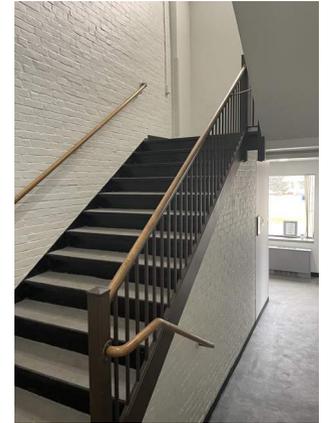
FIRST FLOOR - 90 - OBSERVATIONS

- » Both sets of stairs & railings are not to code. Railing height, extensions noncompliant. Main stair width tight.
- » ACT suspended system damaged.
- » Plumbing fixtures & interior finishes are damaged and outdated.

- » **Code:** Multiple issues with existing railings & stairs, extent of changes will be based on final scope of work.
- » Replace interior finishes throughout.

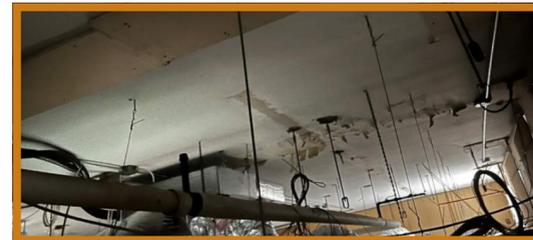
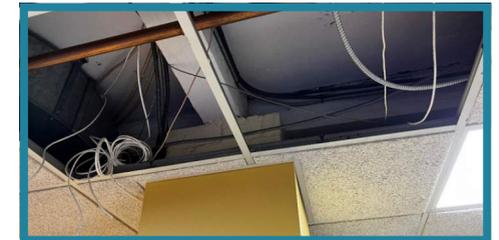
ATTIC - MINIMAL SCOPE - REPAIRS

- » 74 - The roof at the kitchen area includes steel beams supporting tectum roof panels. The original building includes hip and gable roof framing visible from the attic space, found to be in good condition. The roof above the auditorium was not visible but there was no visible signs of deflection.
- » **Recommend: any existing structural members found to be damaged will need to be evaluated for reinforcement or replacement, but otherwise good condition.**
- » 90 - Roof framing at center of building was mostly covered with finishes and not visible. Finishes show no sign of significant cracks. Framing includes 2x8 wood rafters framing to a 2x10 valley beam. Framing visible at both building ends in good condition. Rafters and beam in good condition with no sign of deflection or distress.

- » **Recommend: any existing structural members found to be damaged will need to be evaluated for reinforcement or replacement, but otherwise good condition.**

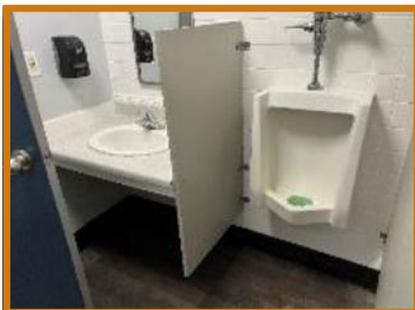
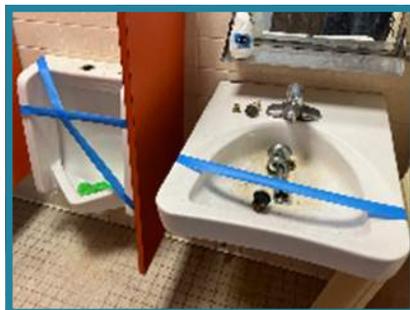
Plumbing Fixtures

- » 74 - Bathroom fixtures generally appear to be in good to excellent condition. Janitor's closet sinks in fair to poor condition. Kitchen fixtures are in fair to good condition and include a dedicated grease trap for the triple pot sink.
- » **Recommend: Fixtures in good condition to remain can serve shared spaces. New distribution and plumbing fixtures for new residential layout.**
- » 90 - Bathroom fixtures generally appear to be in fair condition, several have been demolished or damaged beyond repair.
- » **Recommend: All new distribution and plumbing fixtures for new residential layout.**

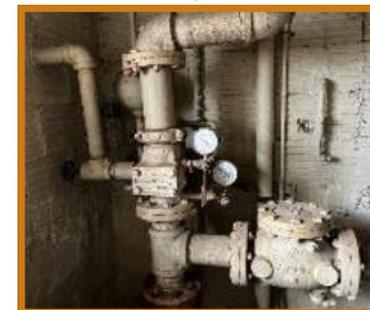
- » 74 - Wet type sprinkler system with sprinklers in basement & attic only. 4" fire protection service is visible and in fair condition. Sprinkler piping is steel and sprinklers are exposed upright type - both in good condition.
- » **Code: sprinkler system required on all floors.**
- » 90 - Combination of wet and dry type sprinkler systems. Wet standpipes in stairwells and dry sprinklers serving the top floor and attic spaces. Fire protection service was not accessible for review. Sprinklers on the top floor and attic spaces are in fair to good condition.
- » **Code: sprinkler system required on all floors.**

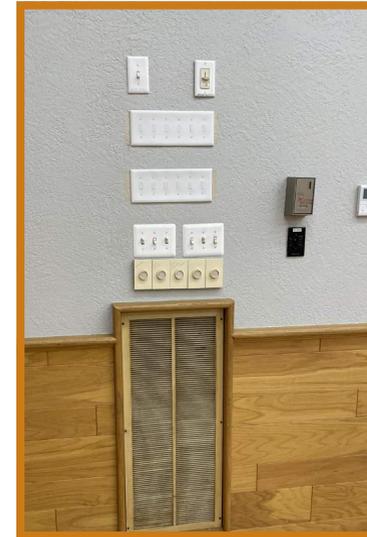
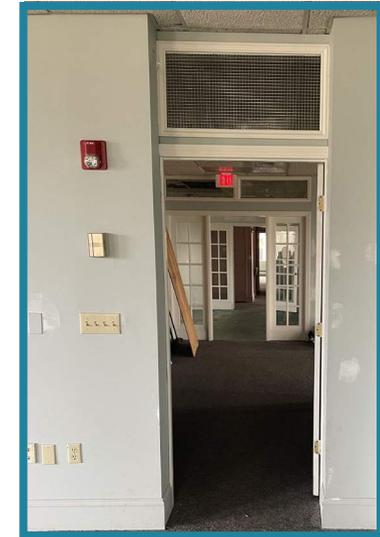
- » 74 & 90 - Controls for heating, cooling and ventilation systems are independent of each other and without building automation or monitoring systems in place. This results in a less-than efficient system where heating and cooling may be occurring simultaneously.
- » **74 & 90 Recommend: New integrated controls and monitoring for shared spaces. Individual controls for residential spaces.**

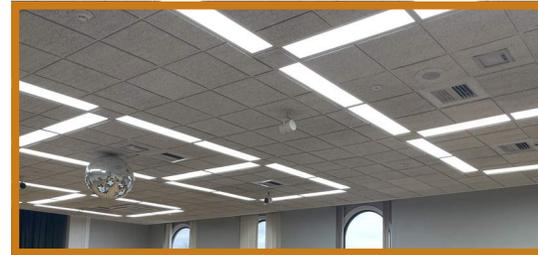
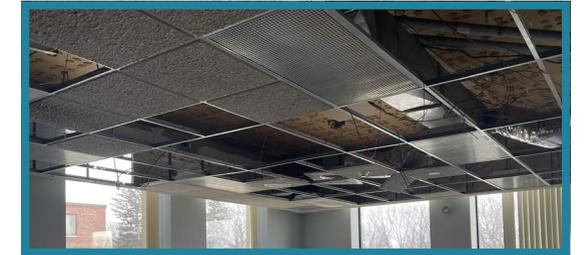
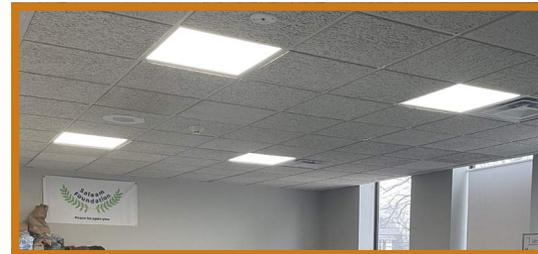
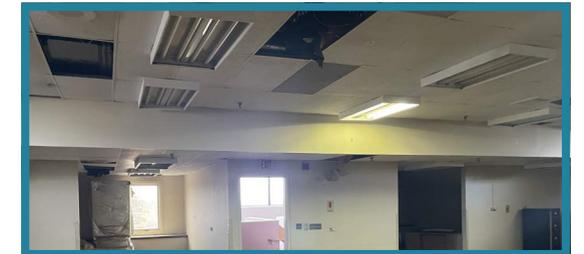
- » 74 - Majority of fixtures consists of 2'x2' fixtures in suspended lay-in ceilings, auditorium includes 1'x4' fixtures, all controlled by manual wall-mounted switches.
- » **Recommend: Install new LED lighting throughout building, include energy saving lighting controls to meet energy code.**
- » 90 - Majority fixtures consists of 2'x2' and 2'x4' fixtures in suspended lay-in ceilings on the lower floors. Top floor includes surface mounted and recessed can type fixtures. All fixtures controlled by manual wall-mounted switches.

- » **Recommend: Install new LED lighting throughout building, include energy saving lighting controls to meet energy code.**
